PRE -AWARD PURCHASER'S REQUIREMENTS CERTIFICATION

As required by Title 49 of the CFR. Part 663 - Subpart B, Department of Rail and Public Transportation (the recipient) certifies that the buses to be purchased, 12-Year Heavy Duty Low-Floor Transit Bus (description of buses) from Gillig, LLC. (the manufacturer), are the same product described in the recipient's solicitation specification and that the proposed manufacturer is a responsible manufacturer with the capability to produce a bus that meets the specifications.

PRODUCT BROCHURE

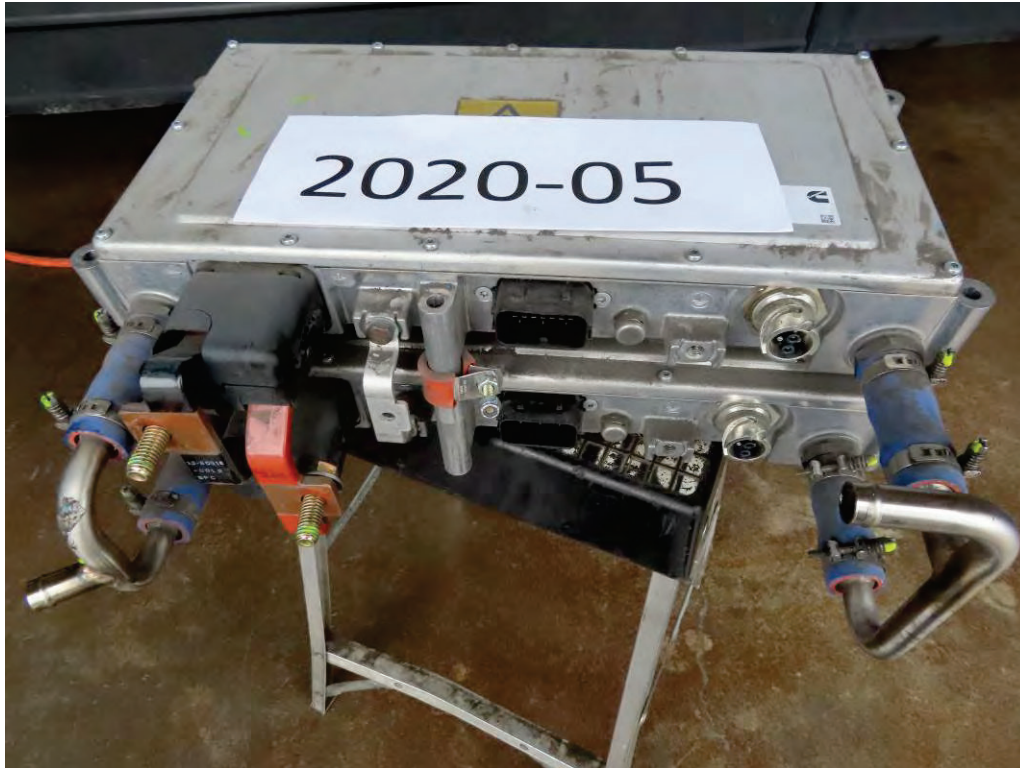
**DC TO DC CONVERTER REMOVAL AND REPLACEMENT
(3.00 LABOR HOURS)**

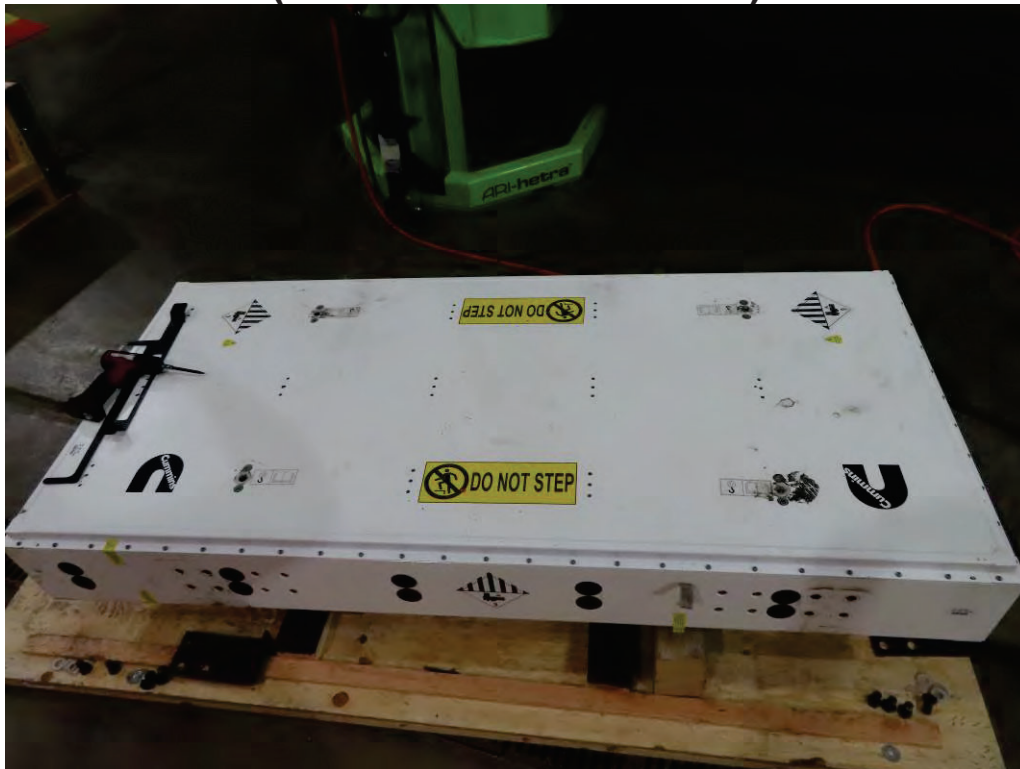
**HIGH VOLTAGE BATTERY REMOVAL AND REPLACEMENT
(10.00 LABOR HOURS)**

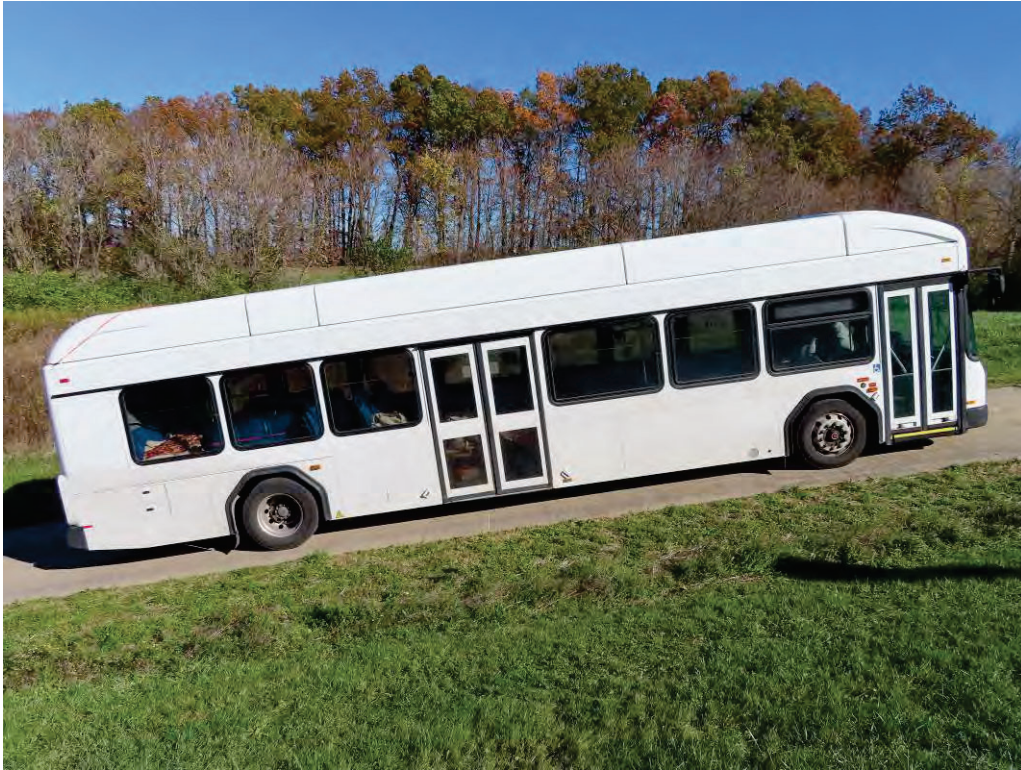
**PARKING BRAKE TEST
PARKING BRAKE HELD FOR 5 MINUTES IN
BOTH 20% UP AND 20% DOWN POSITIONS**

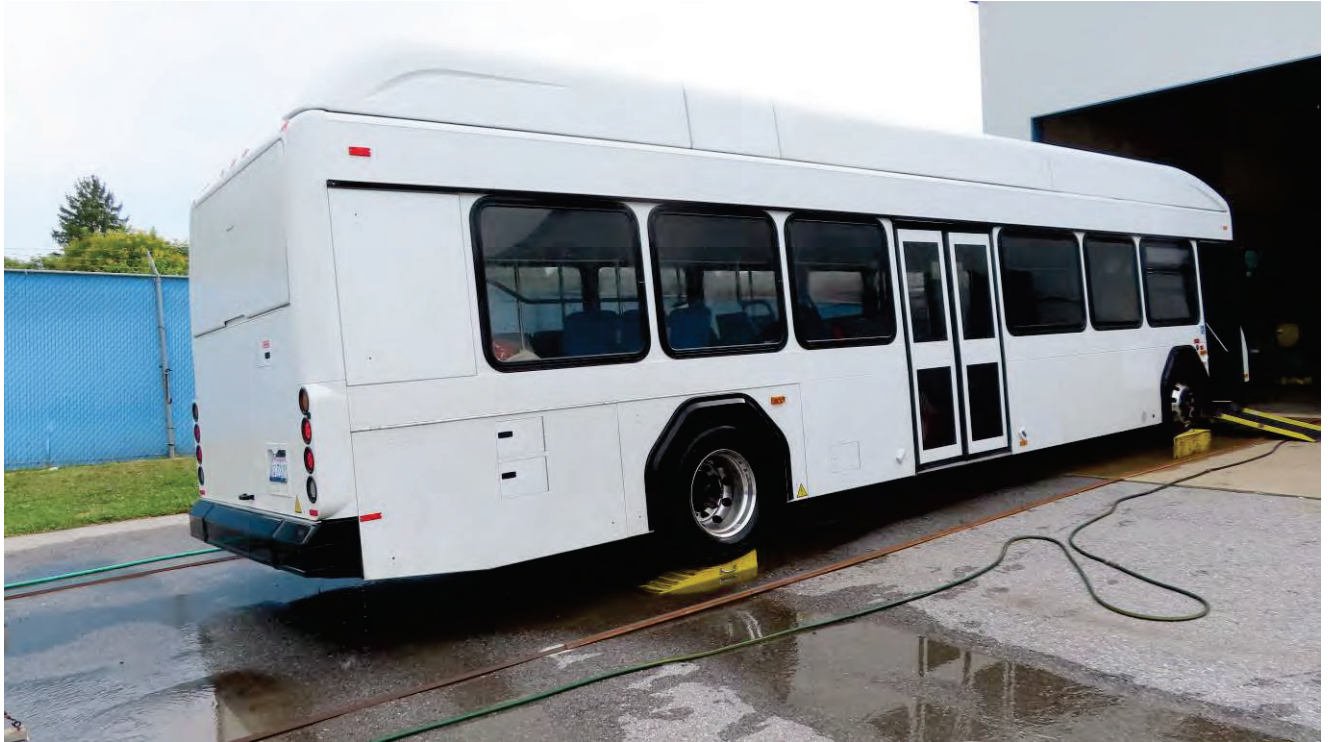
RIGHT REAR WHEEL SIX INCHES HIGHER

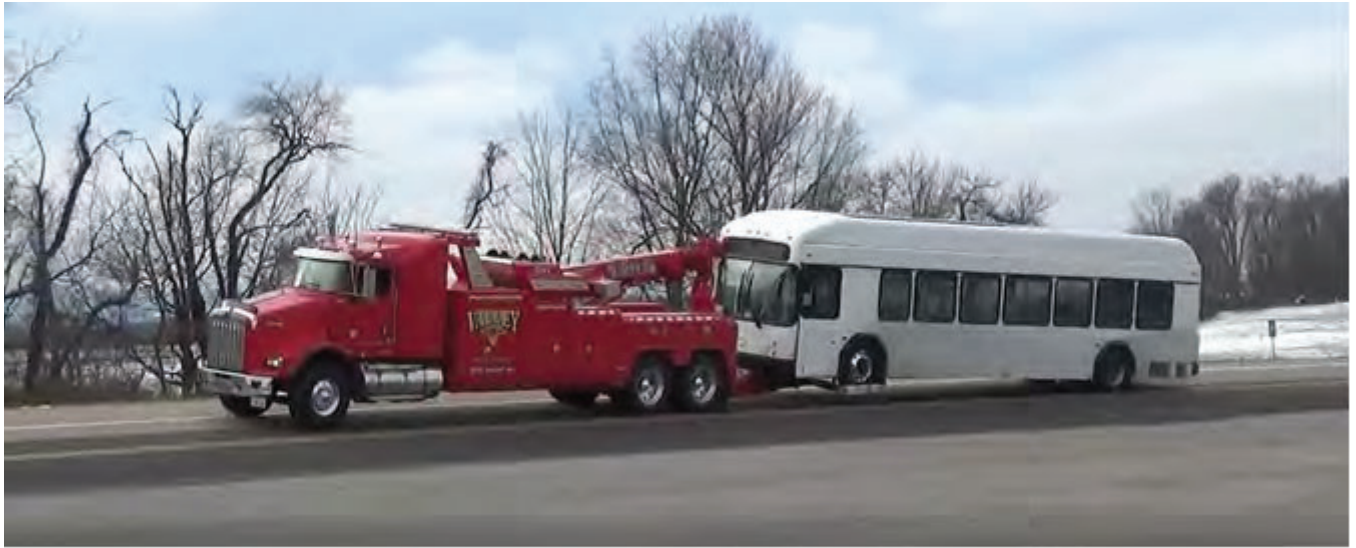
TEST BUS IN TOW

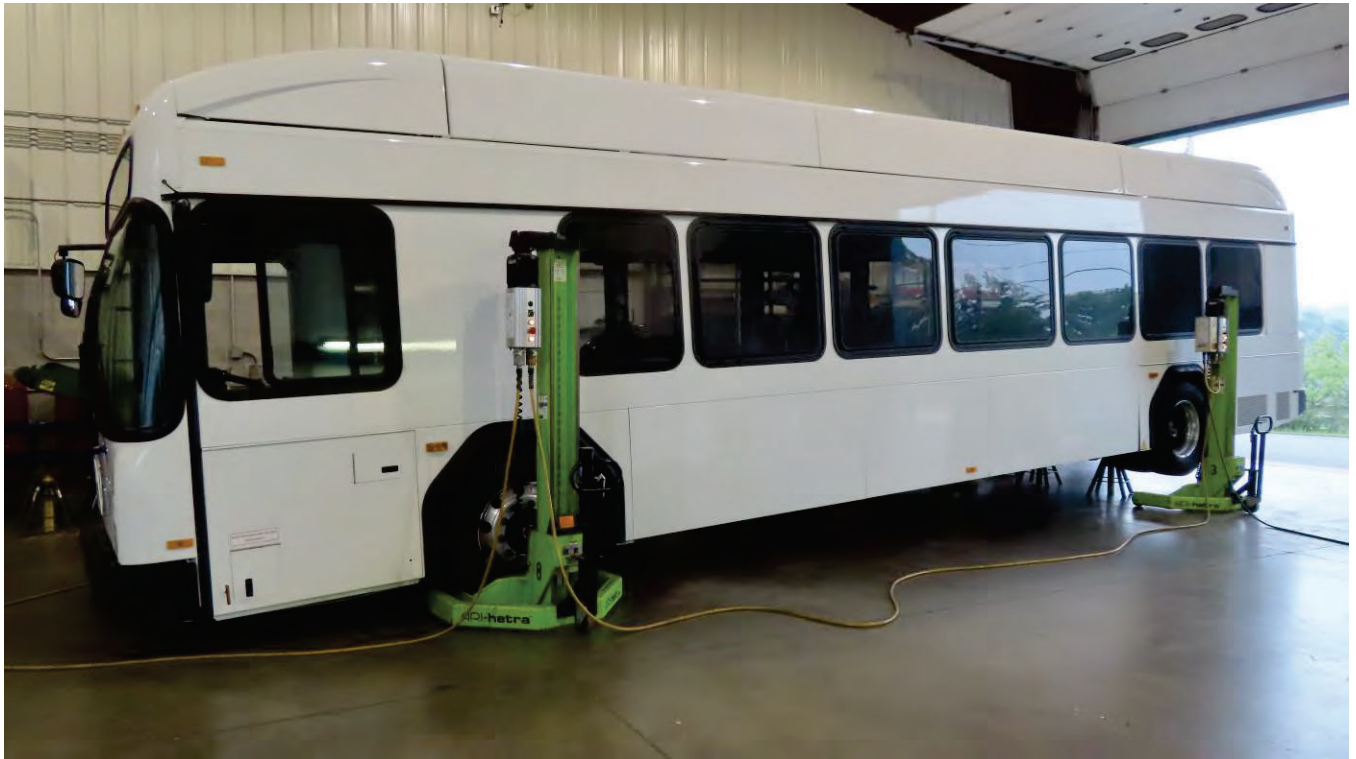
JACK STANDS IN PLACE –REAR

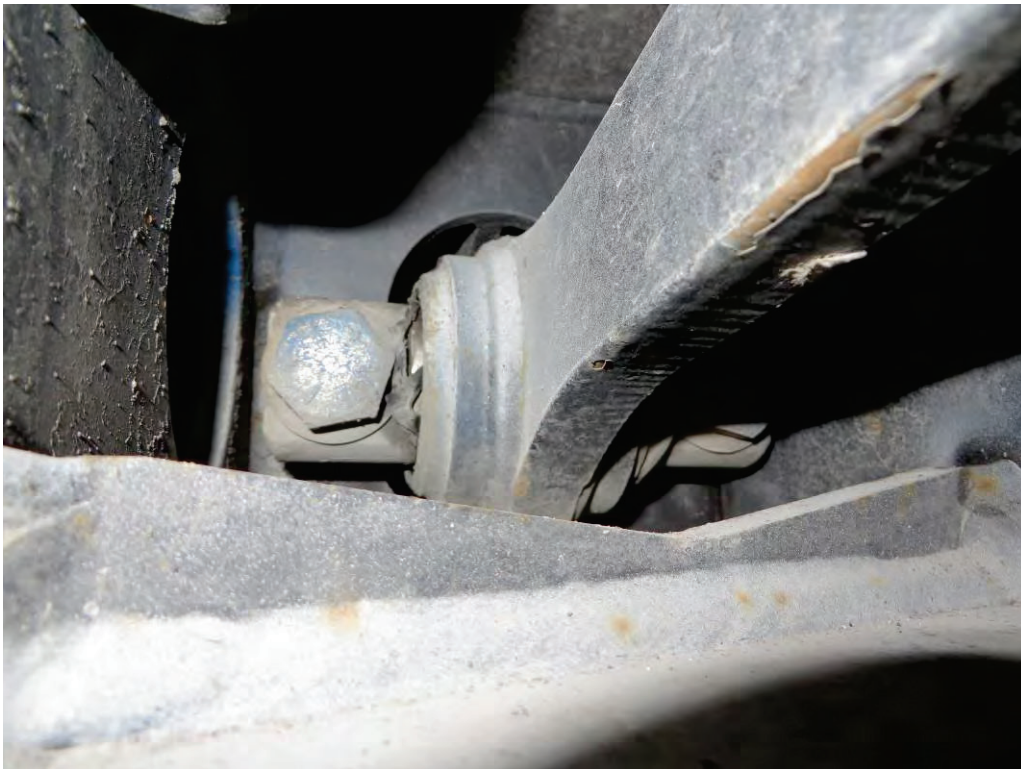
**LOWER REAR TORQUE ARM BUSHINGS ARE WORN OUT
(12,354 TEST MILES)**

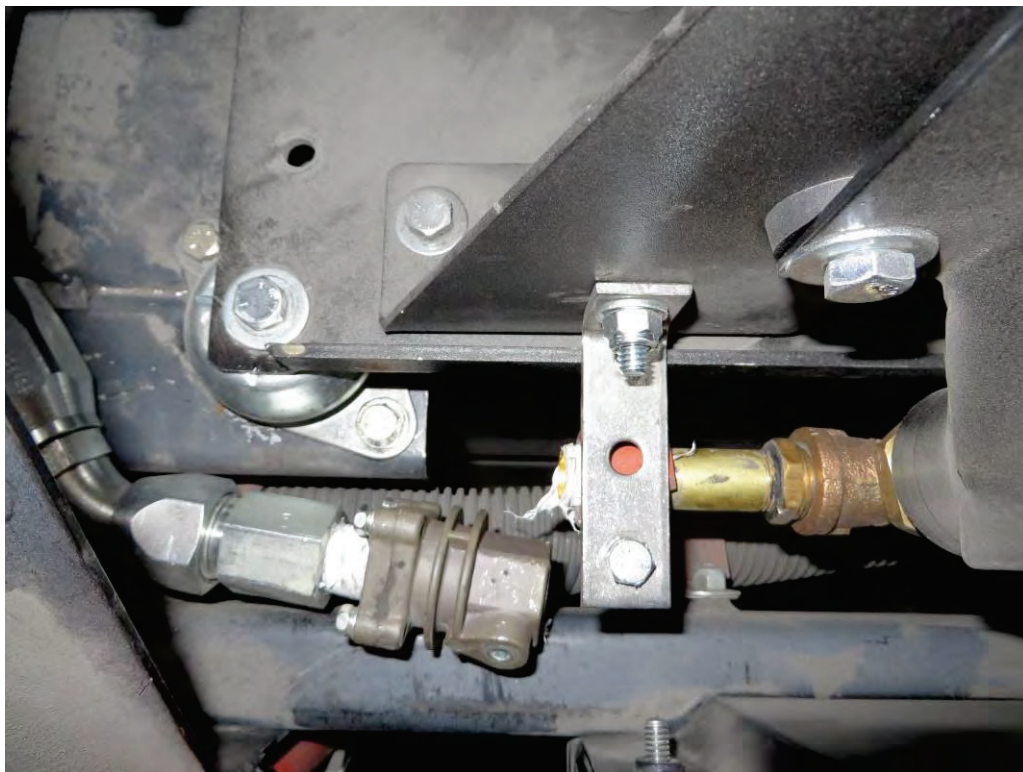
**BRASS PIPE BROKEN ON SIDE OF AIR COMPRESSOR
(12,443 TEST MILES)**

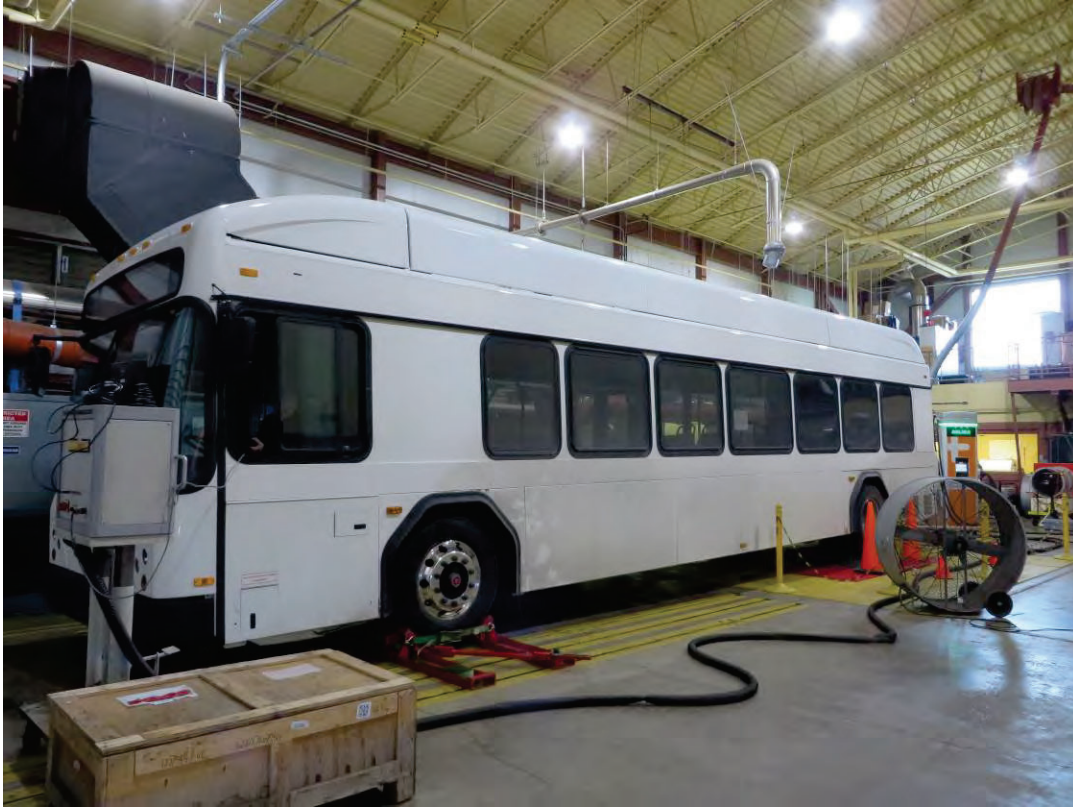
BUS TESTED ON CHASSIS DYNAMOMETER FOR PERFORMANCE AND FUEL ECONOMY

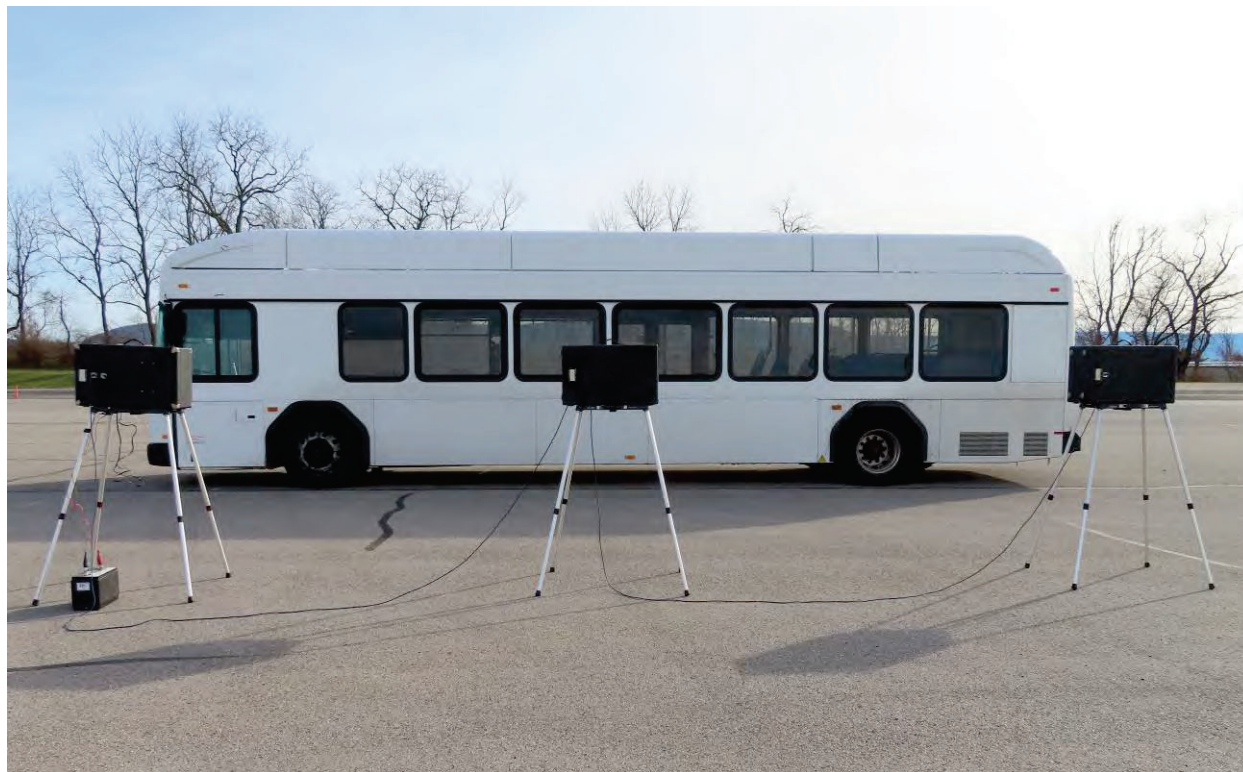
**TEST BUS SET-UP FOR 80 dB(A)
INTERIOR NOISE TEST**

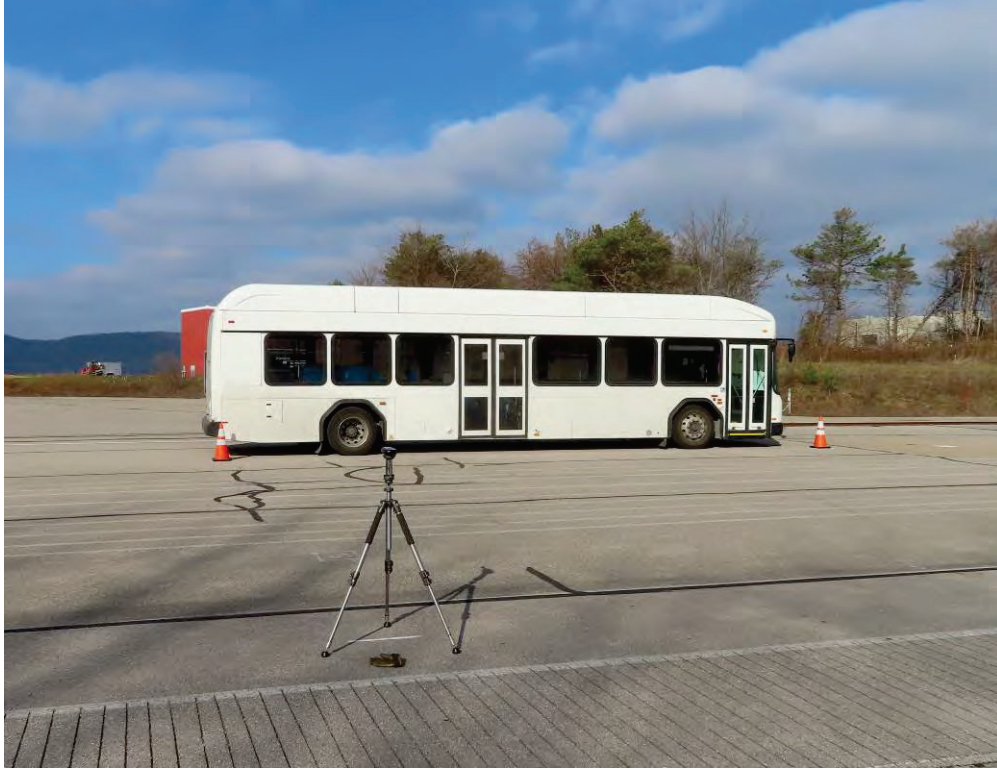
TEST BUS UNDERGOING EXTERIOR NOISE TESTING

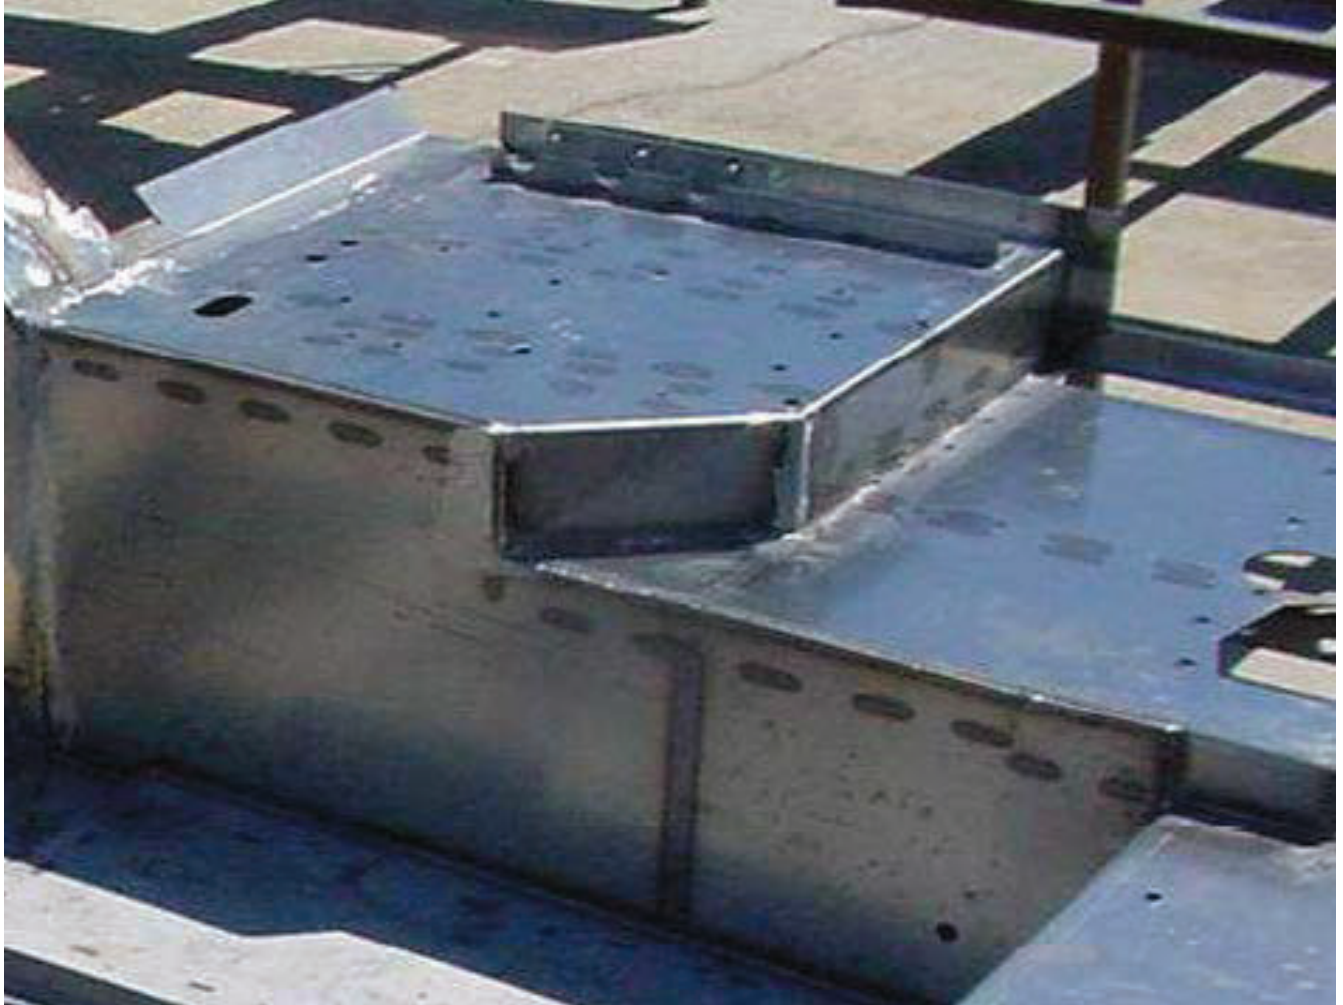
Stainless Steel Drivers Platform

For the driver's safety, GILLIG provides a Stainless driver's platform integrated into the bus chassis. This platform allows the driver to be protected from the typical accident strike zone. It also provides better driver visibility and allows the seated driver to be at a similar level as a passenger standing in the step well.

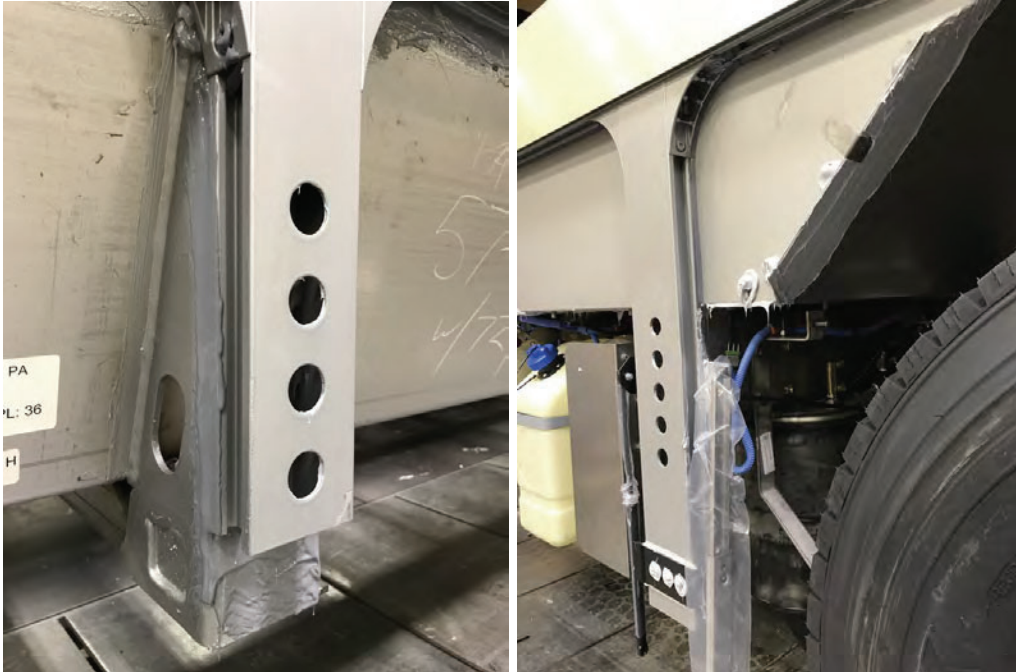
Before the body is connected to the chassis with Geomet hardware, a specially formulated hybrid epoxy/sealant coating is applied to the mating surfaces to add mechanical strength and seal out corrosive elements. After the connection is made, all joints are redundantly sealed.

Left: Protected & sealed body/chassis connection. Right: Sealed wheel well and stress panel arch.

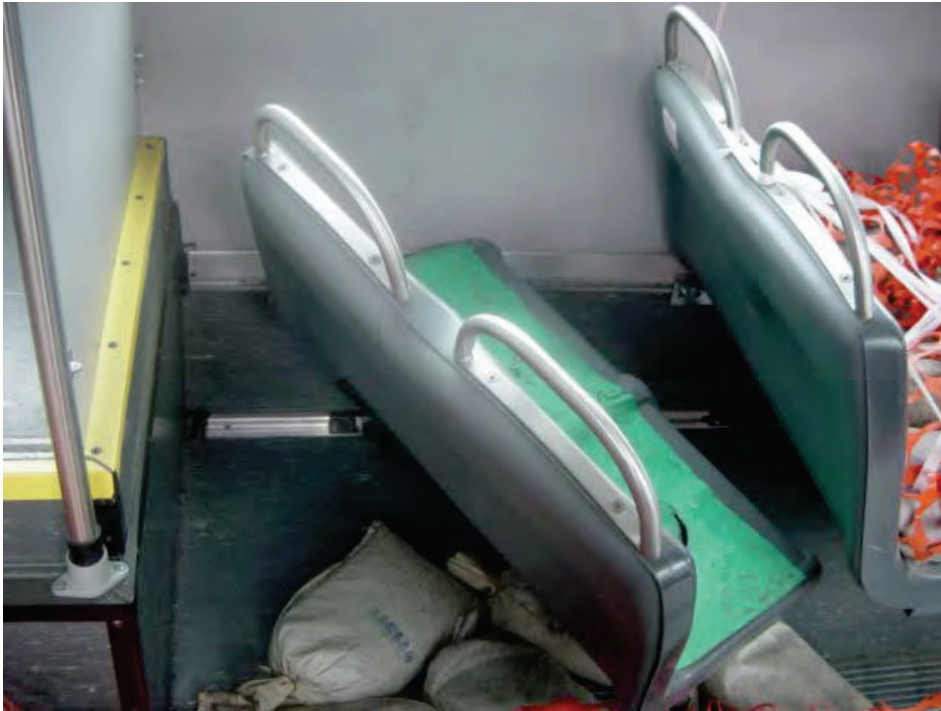
**BROKEN SEAT FRAME
(5,500 TEST MILES)**

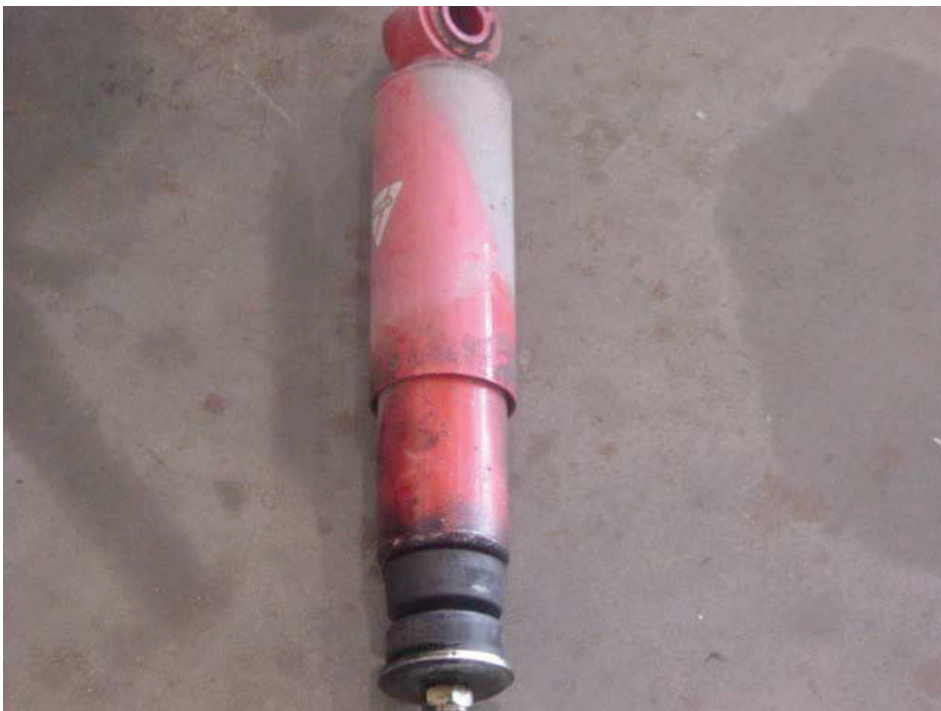
**BROKEN LEFT FRONT SHOCK
(9,974 TEST MILES)**

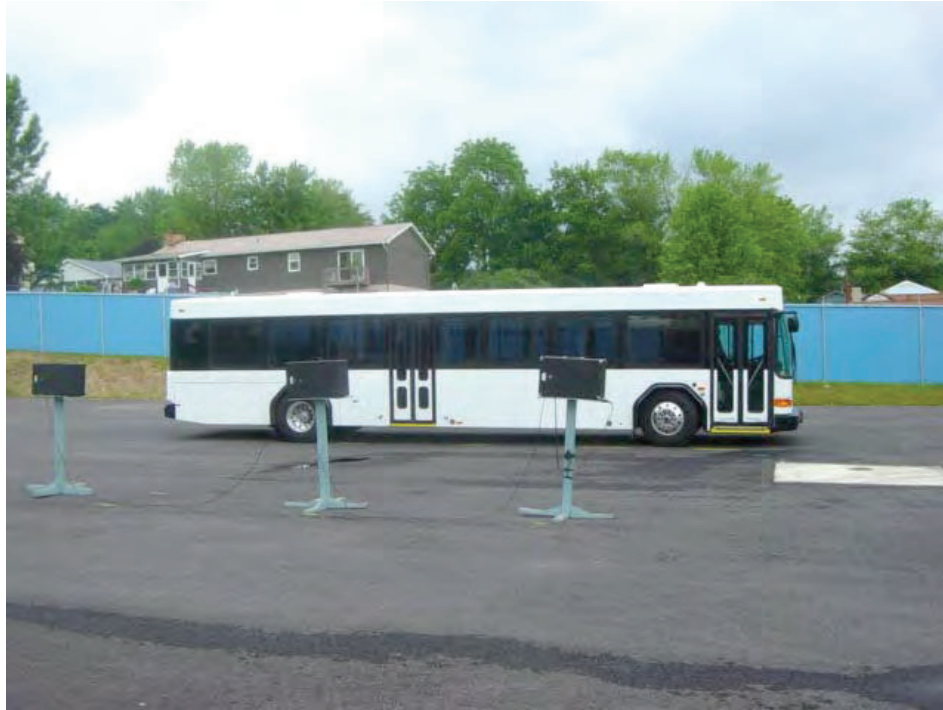
**TEST BUS SET-UP FOR 80 dB(A)
INTERIOR NOISE TEST**

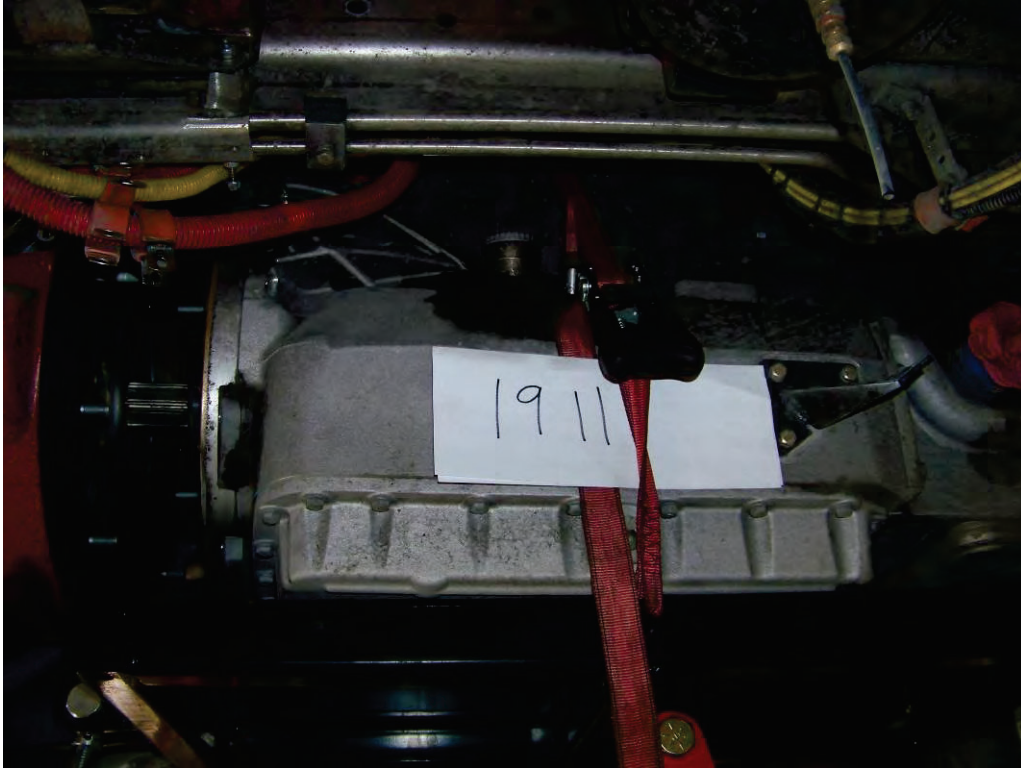
**TRANSMISSION REMOVAL AND REPLACEMENT
(6.00 LABOR HOURS)**

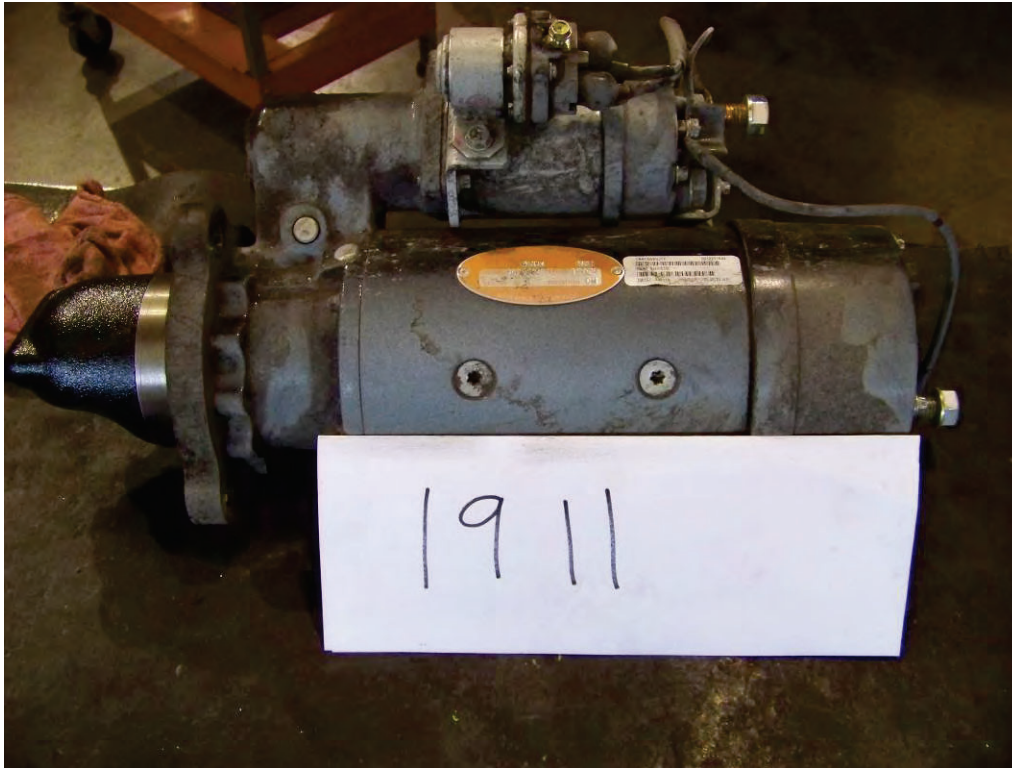
**STARTER REMOVAL AND REPLACEMENT
(1.00 LABOR HOUR)**

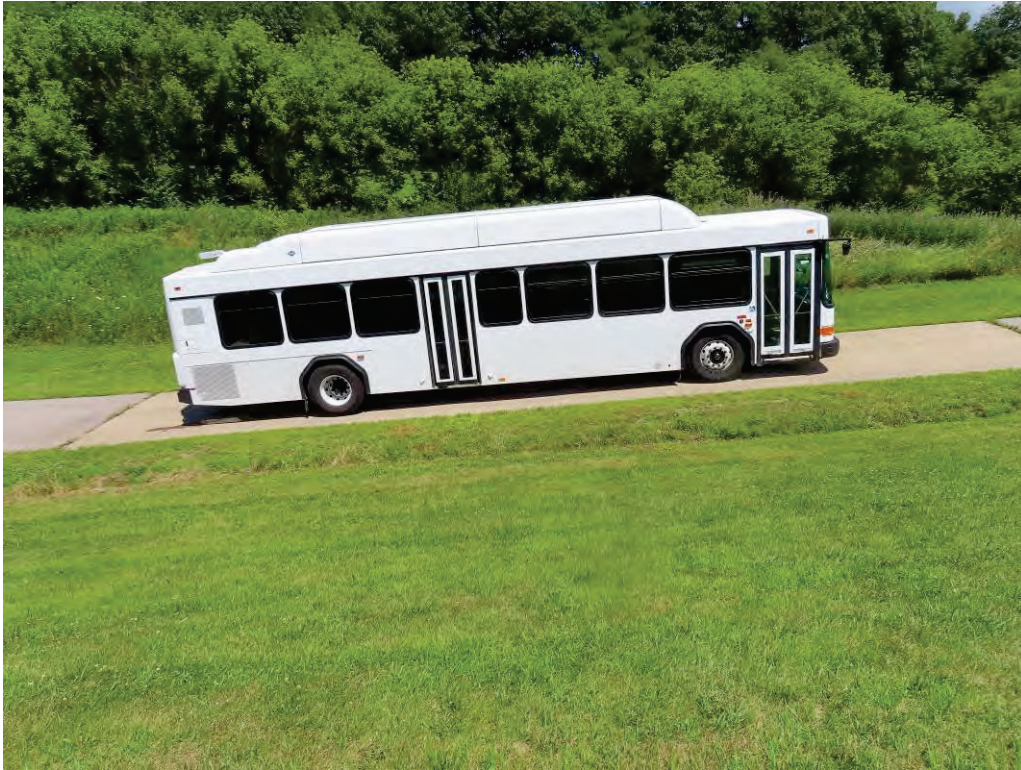
**PARKING BRAKE TEST
PARKING BRAKE HELD FOR 5 MINUTES IN
BOTH 20% UP AND 20% DOWN POSITIONS**

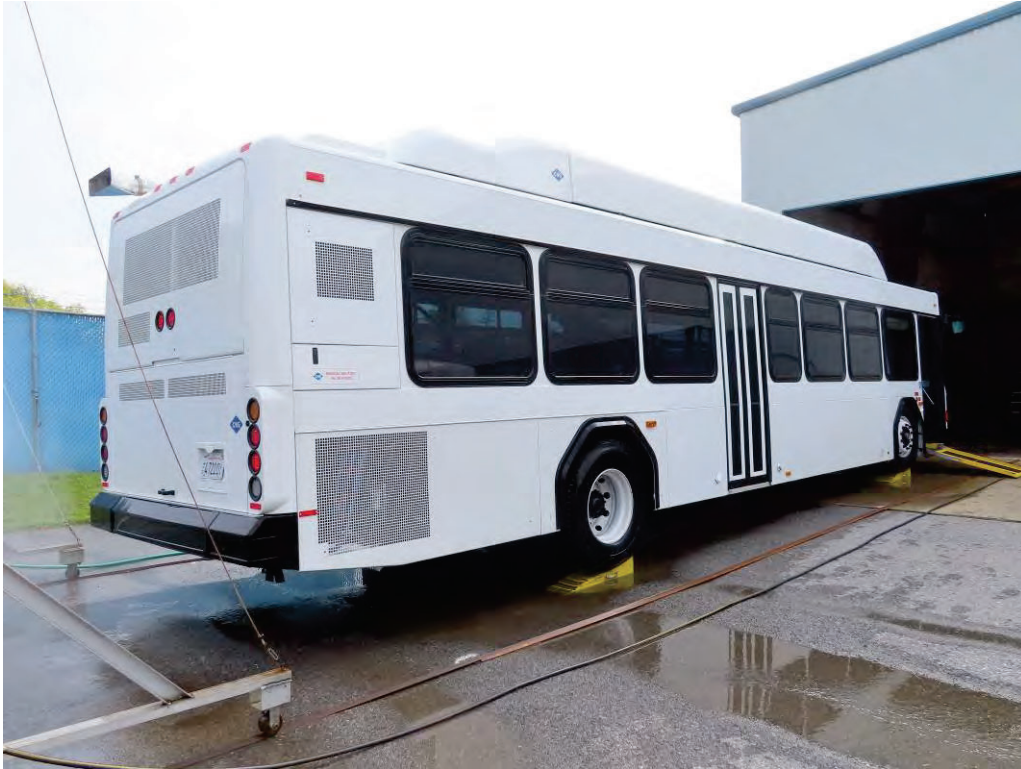
LEFT REAR WHEELS SIX INCHES LOWER

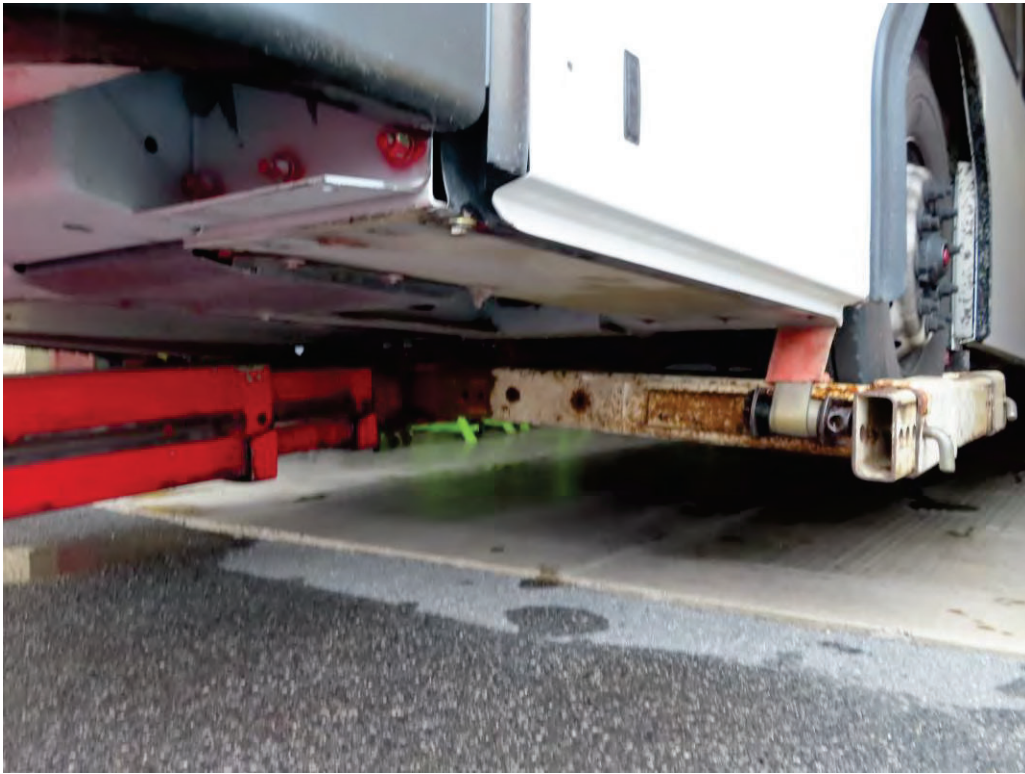
TOWING INTERFACE

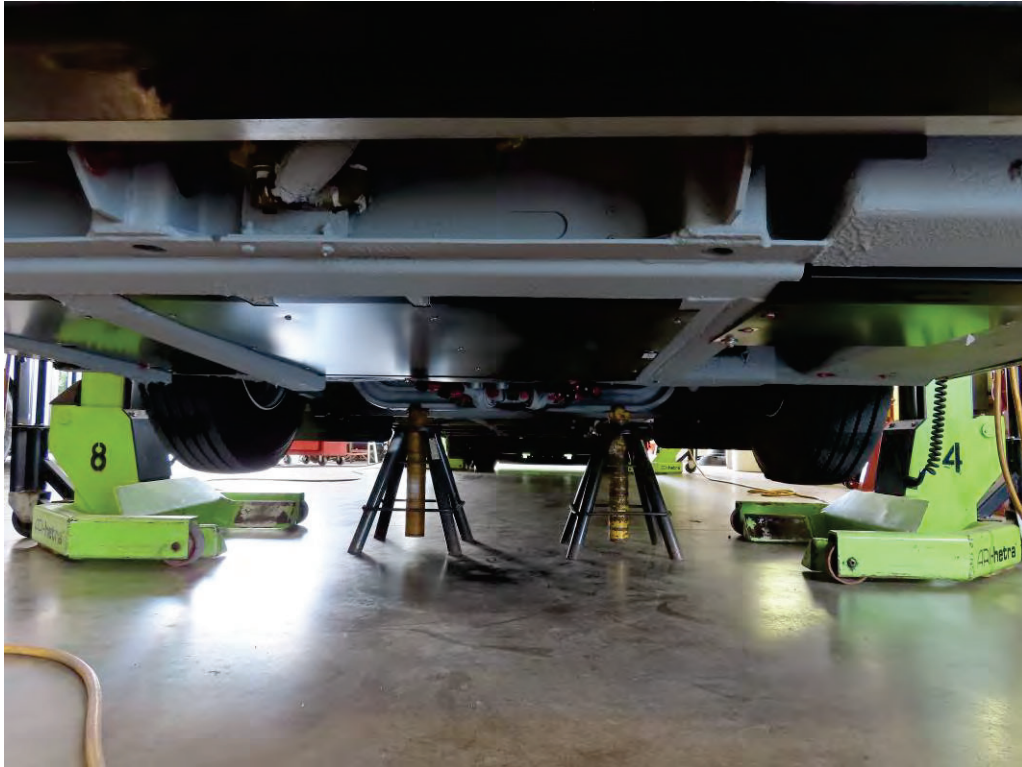
JACK STANDS IN PLACE-FRONT OF BUS

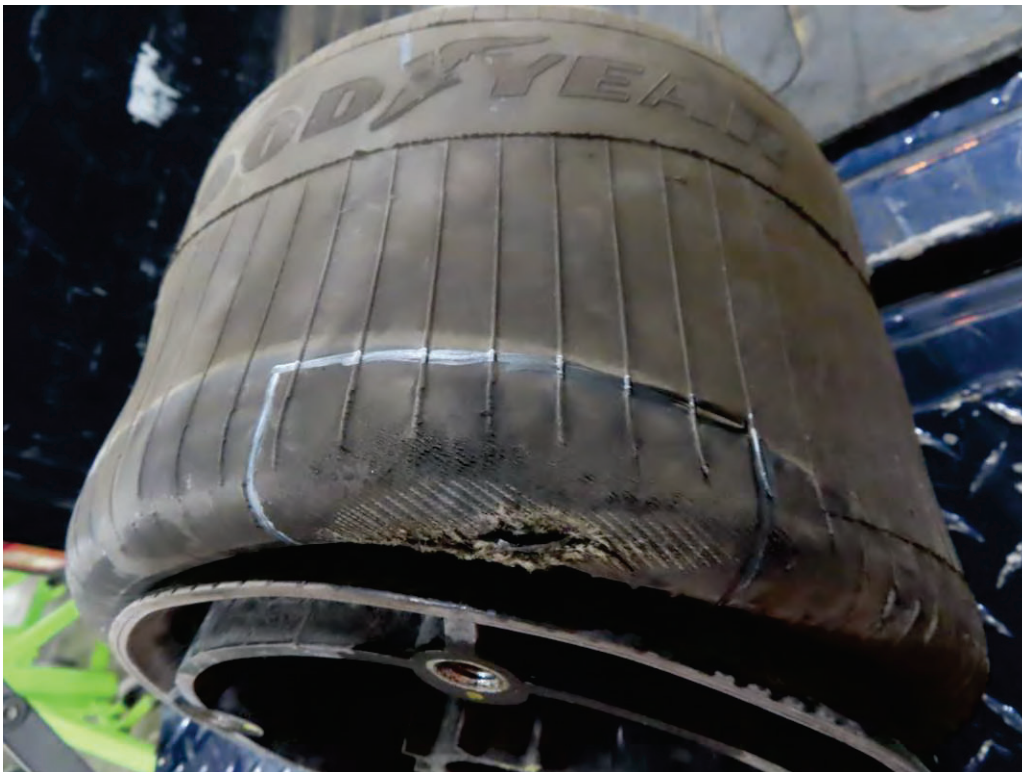
**DRIVER'S SIDE FRONT AIR BAG LEAKING
(10,976 TEST MILES)**

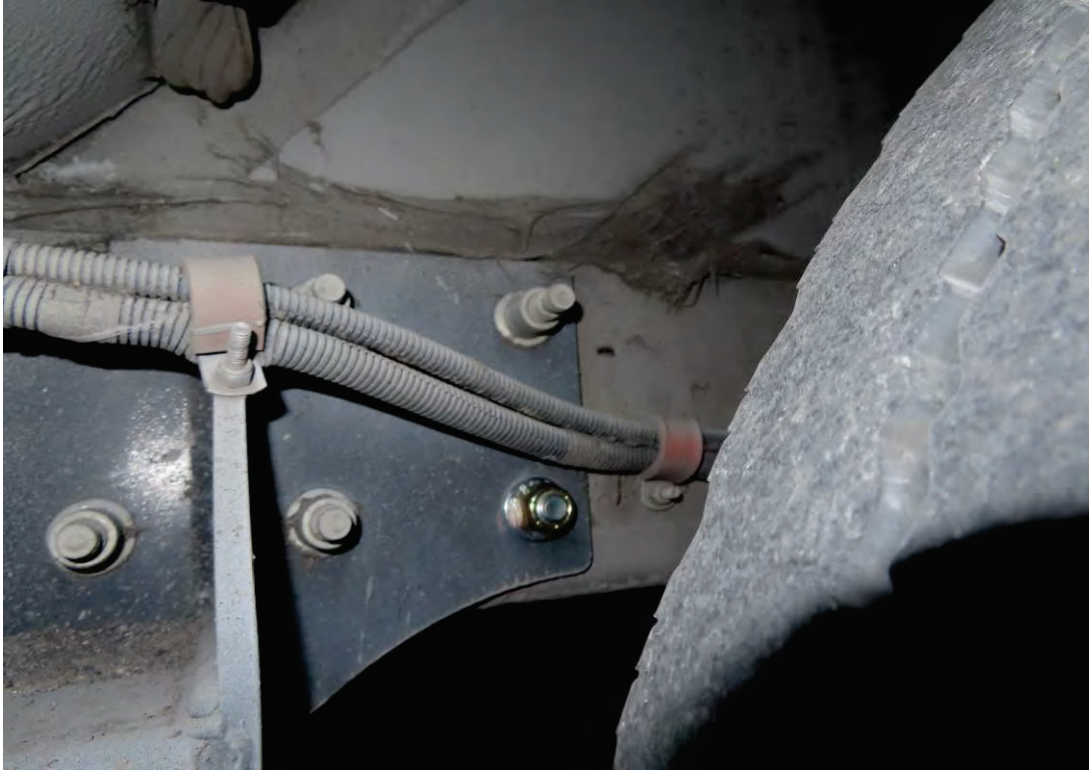
**BROKEN HUCK BOLT REPLACED
(11,491 TEST MILES)**

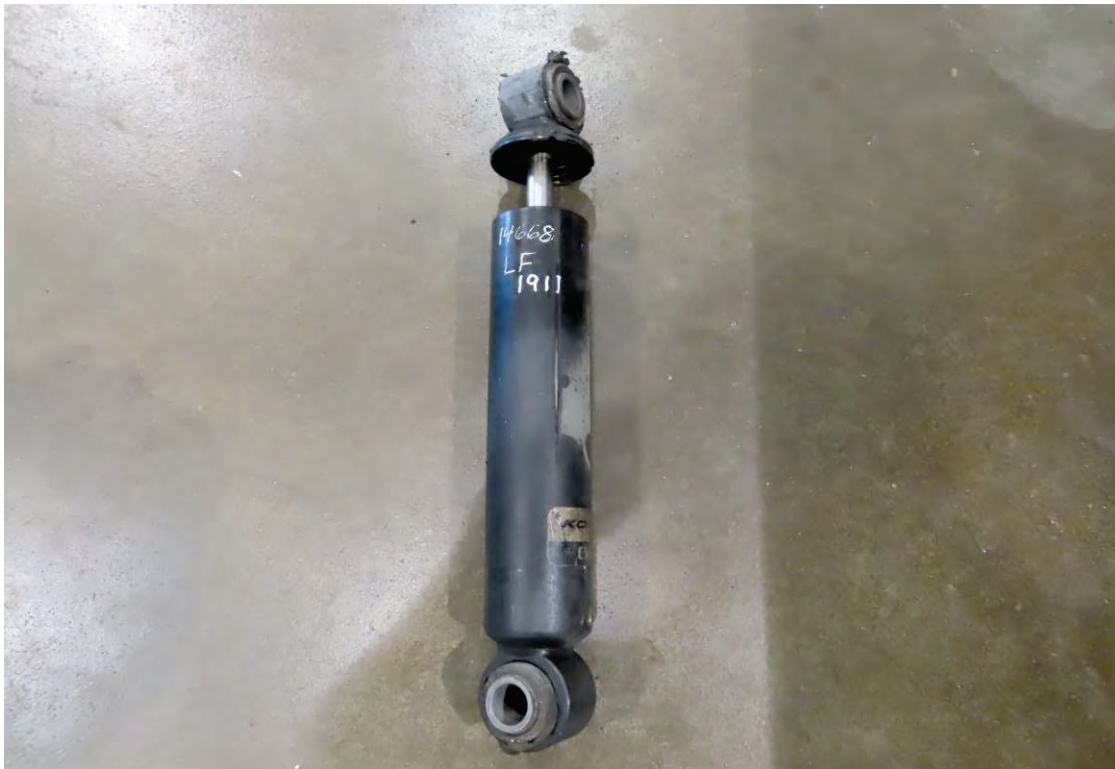
**FRONT SHOCK LEAKING
(11,491 TEST MILES)**

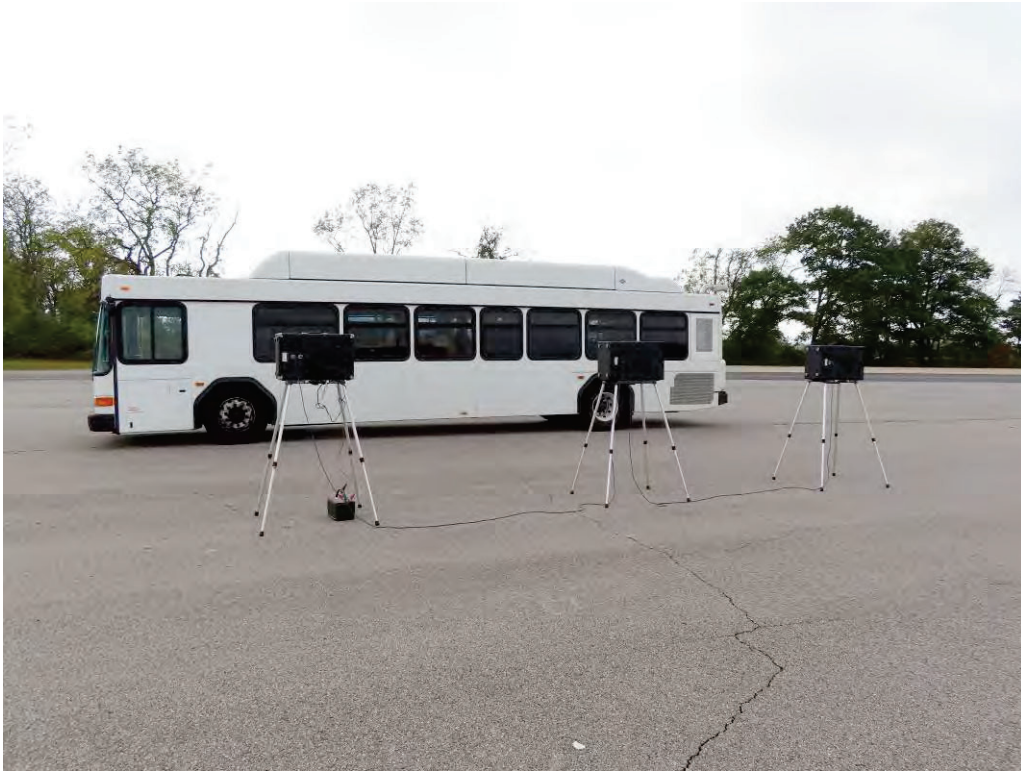
**TEST BUS SET-UP FOR 80 dB(A)
INTERIOR NOISE TEST**

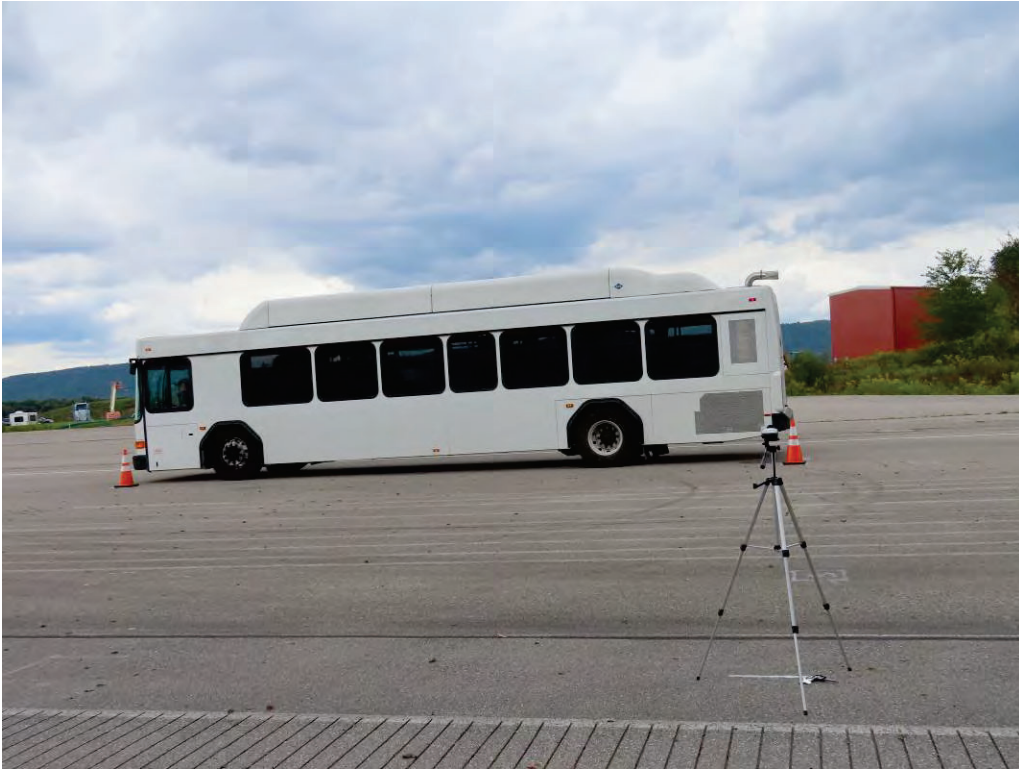
TEST BUS UNDERGOING EXTERIOR NOISE TESTING
