PRE -AWARD PURCHASER'S REQUIREMENTS CERTIFICATION

As required by Title 49 of the CFR. Part 663 - Subpart B, Department of Rail and Public Transportation (the recipient) certifies that the buses to be purchased, 12-Year Heavy Duty Low-Floor Transit Bus (description of buses) from Gillig, LLC. (the manufacturer), are the same product described in the recipient's solicitation specification and that the proposed manufacturer is a responsible manufacturer with the capability to produce a bus that meets the specifications.

PRODUCT BROCHURE

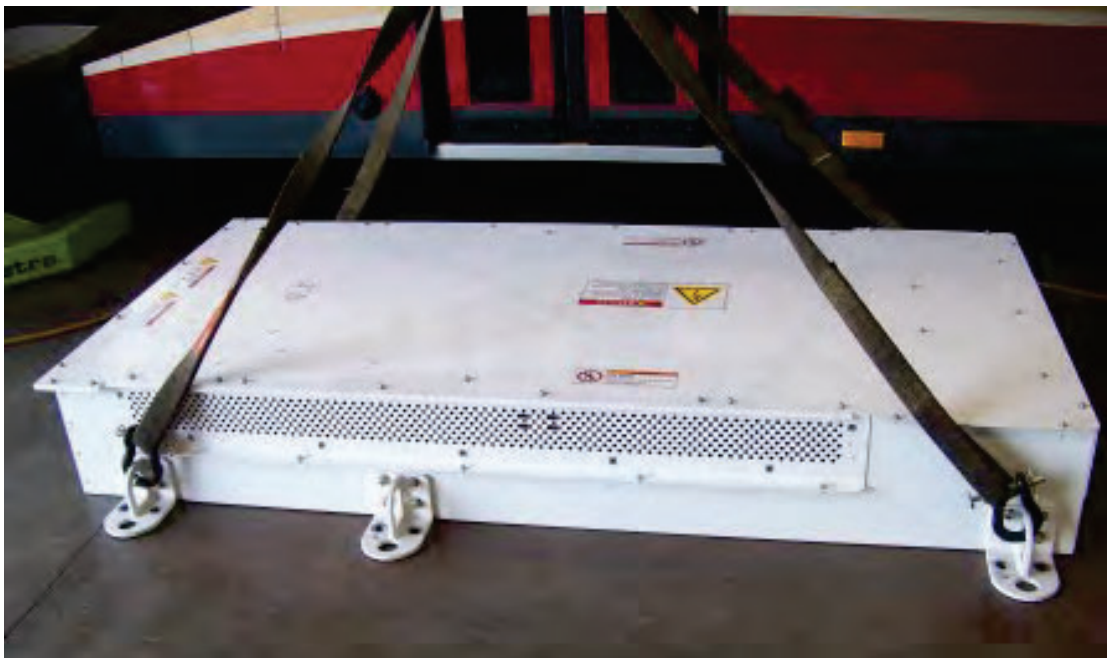
HYBRID BATTERY PACK REMOVAL AND REPLACEMENT (1.50 MAN HOURS)

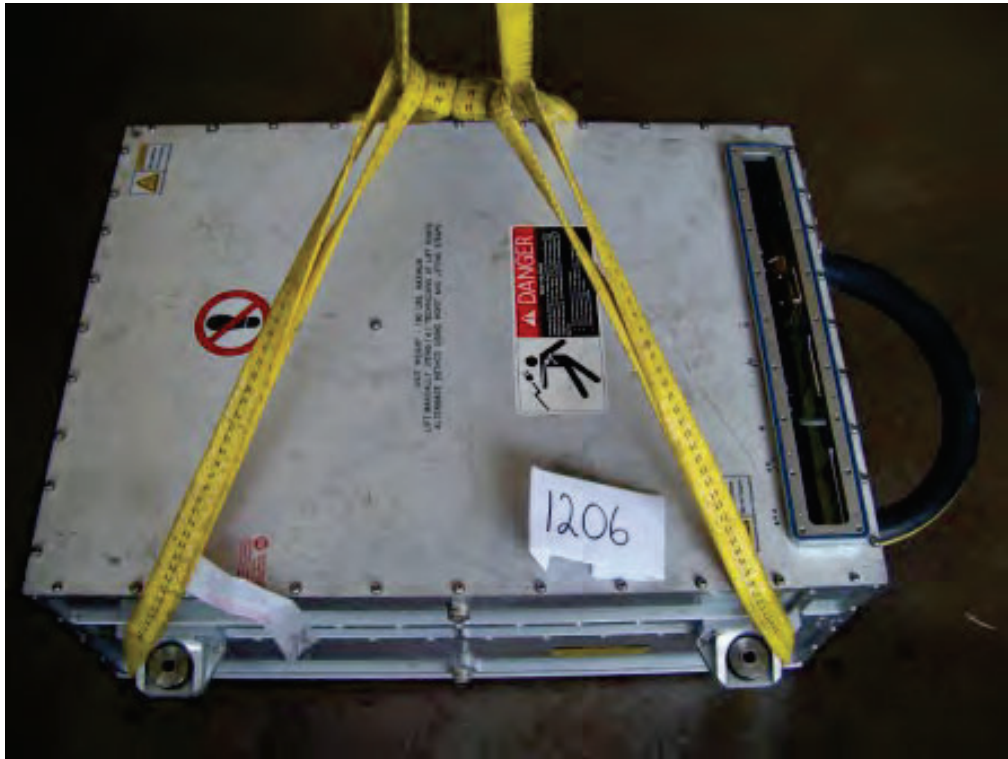
ACCESSORY POWER SYSTEM REMOVAL AND REPLACEMENT (1.00 MAN HOUR)

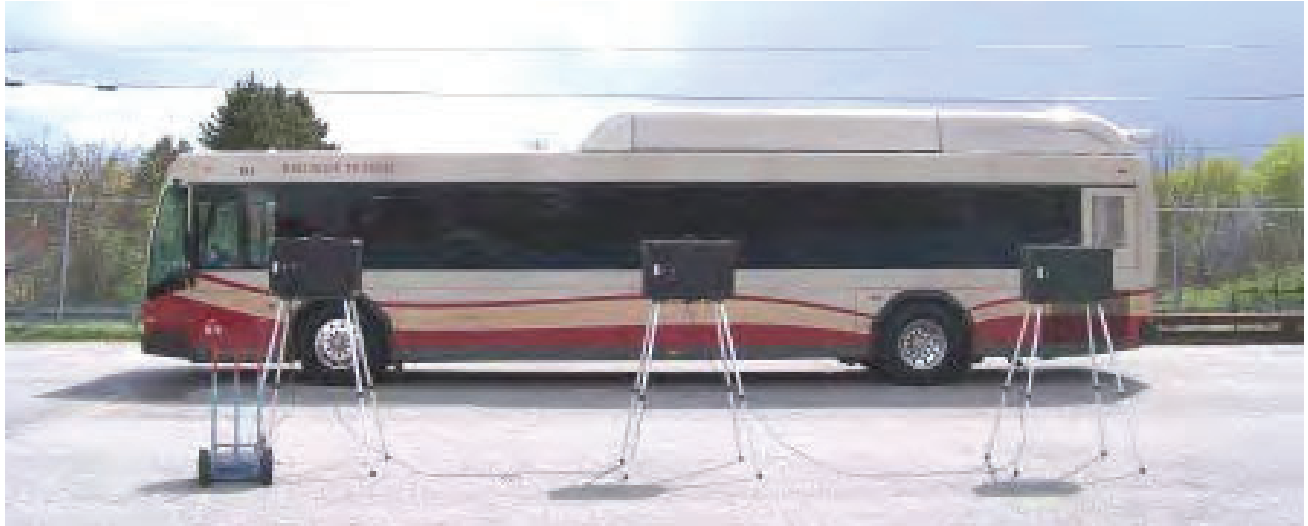
**TEST BUS SET-UP FOR 80 dB(A)
INTERIOR NOISE TEST**

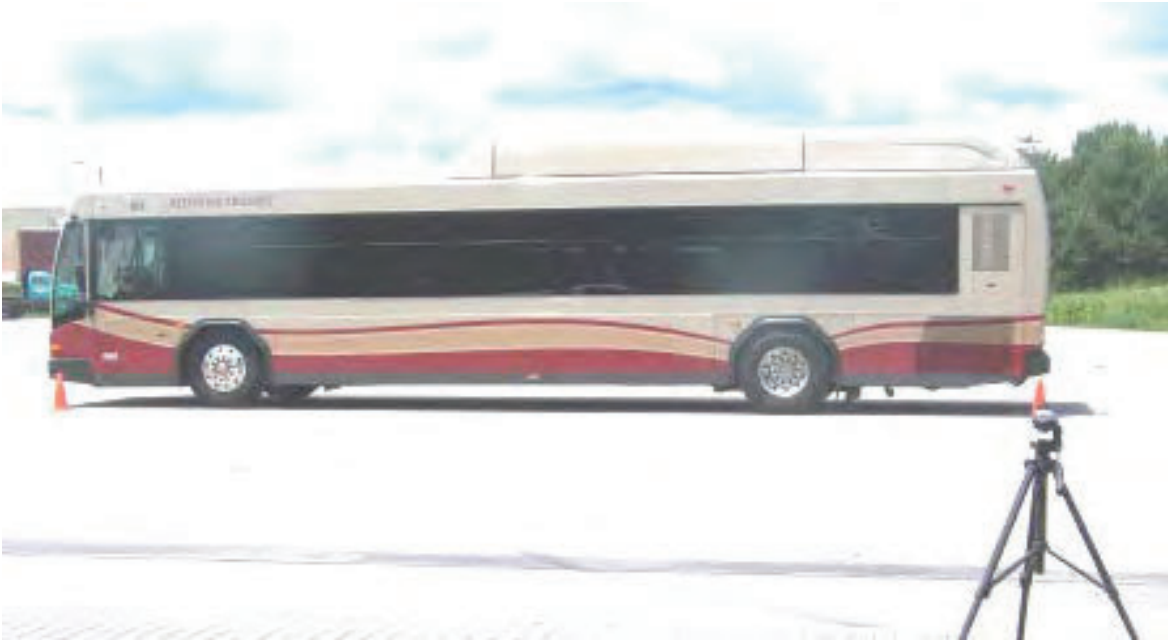
TEST BUS UNDERGOING EXTERIOR NOISE TESTING

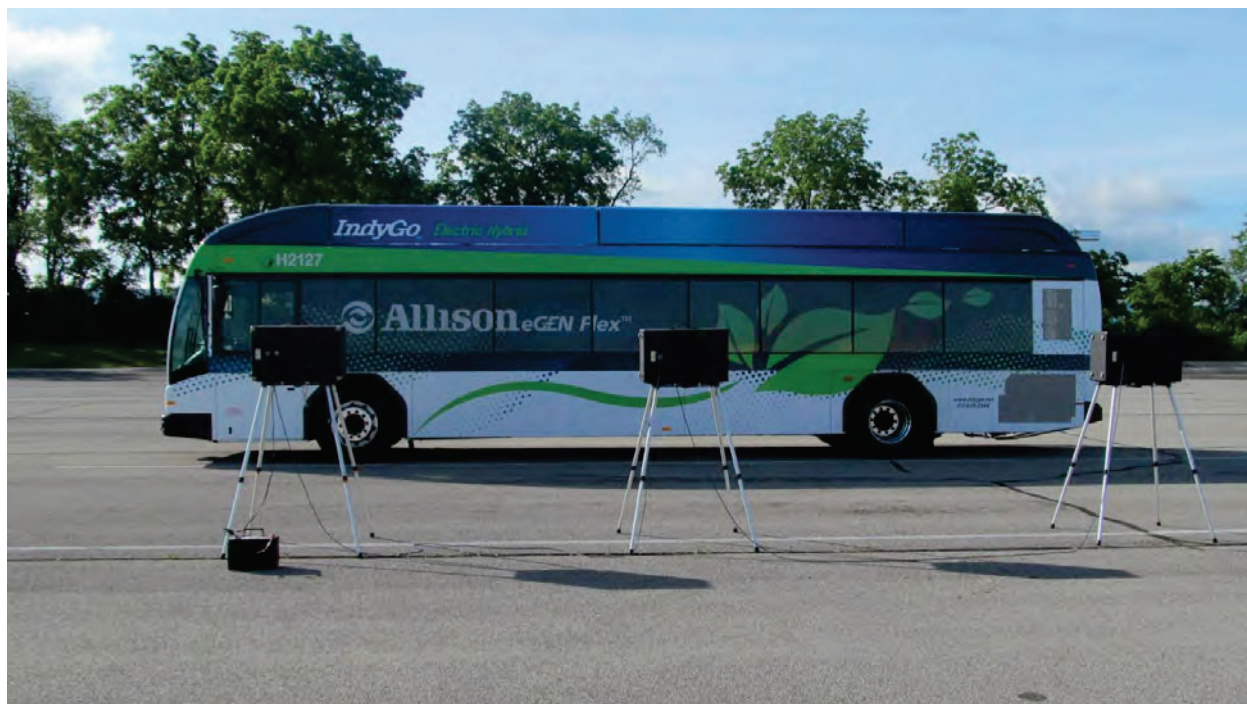
**TEST BUS SET-UP FOR 80 dB(A)
INTERIOR NOISE TEST**

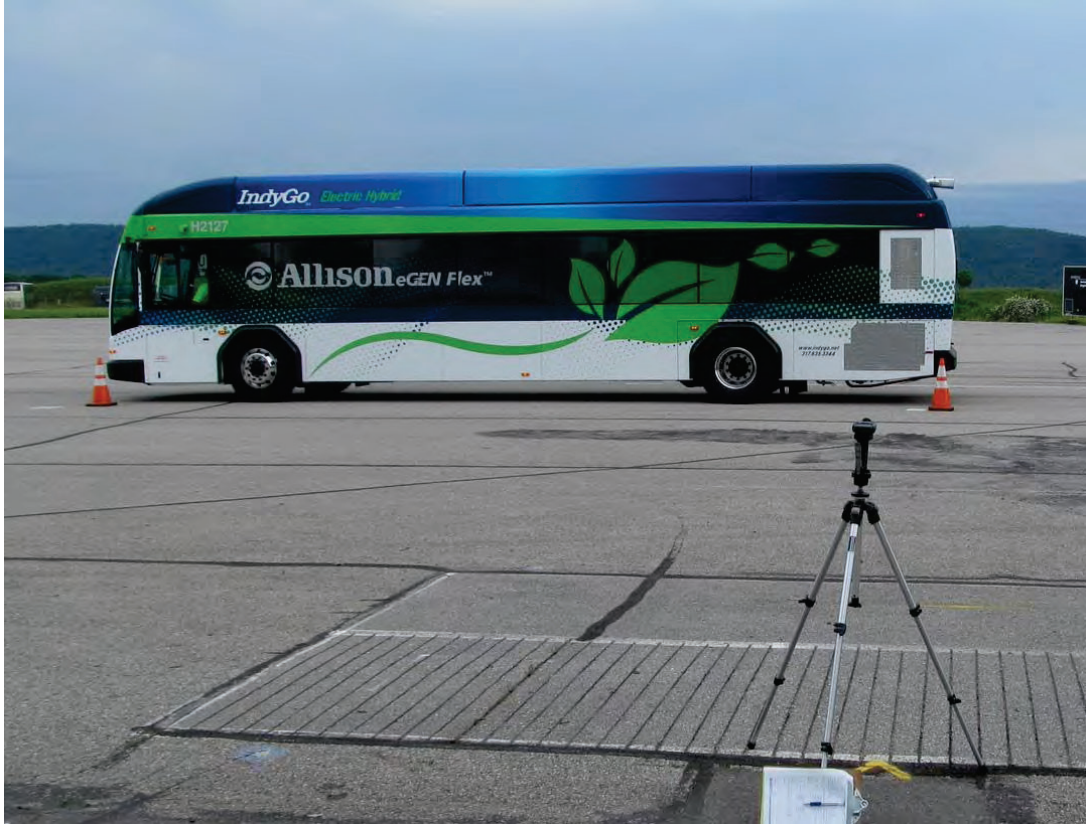
TEST BUS UNDERGOING EXTERIOR NOISE TESTING

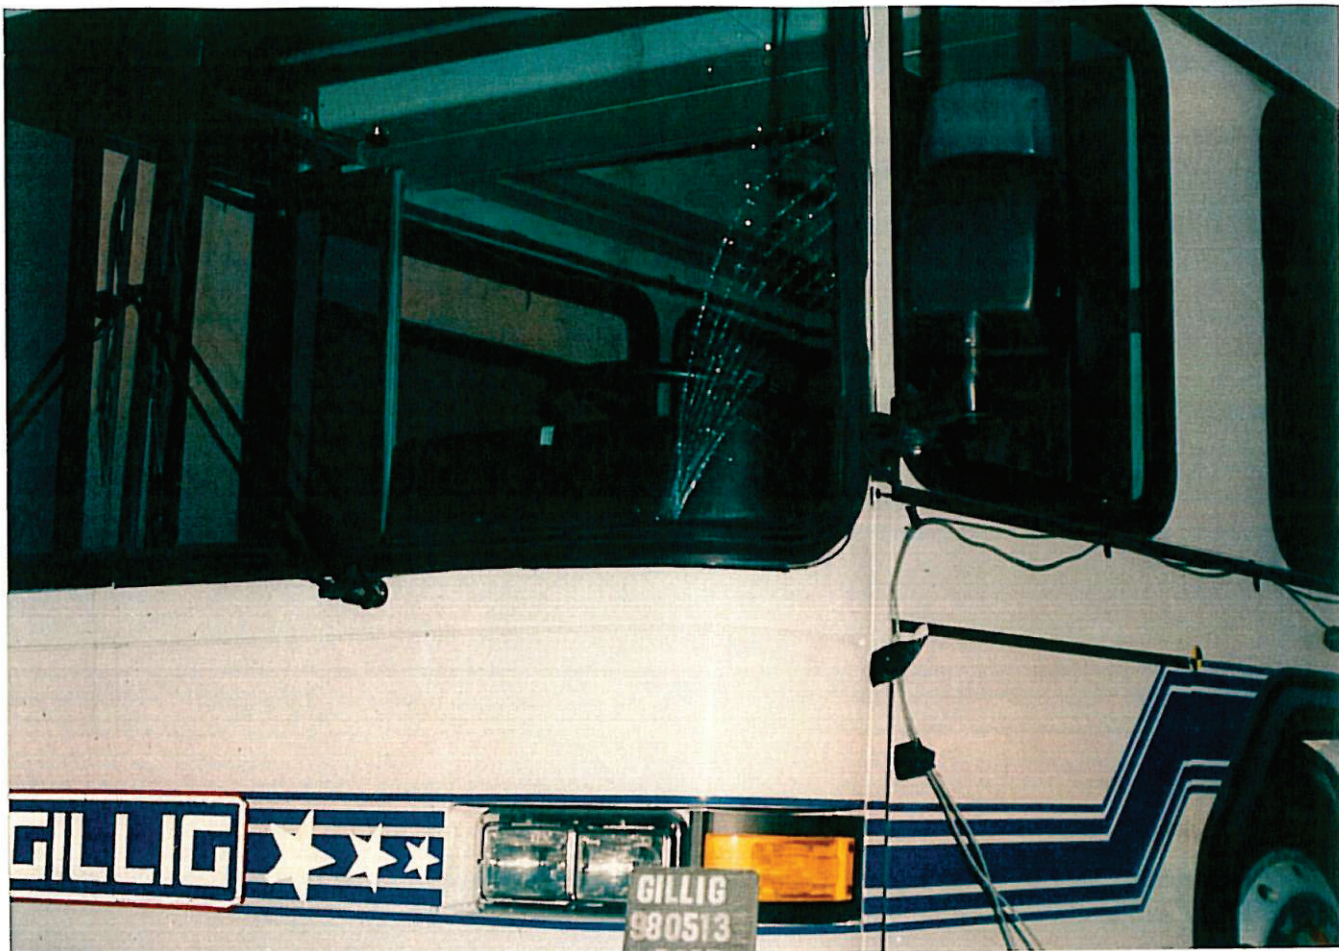
Figure A-24 Post-Test Windshield Damage View

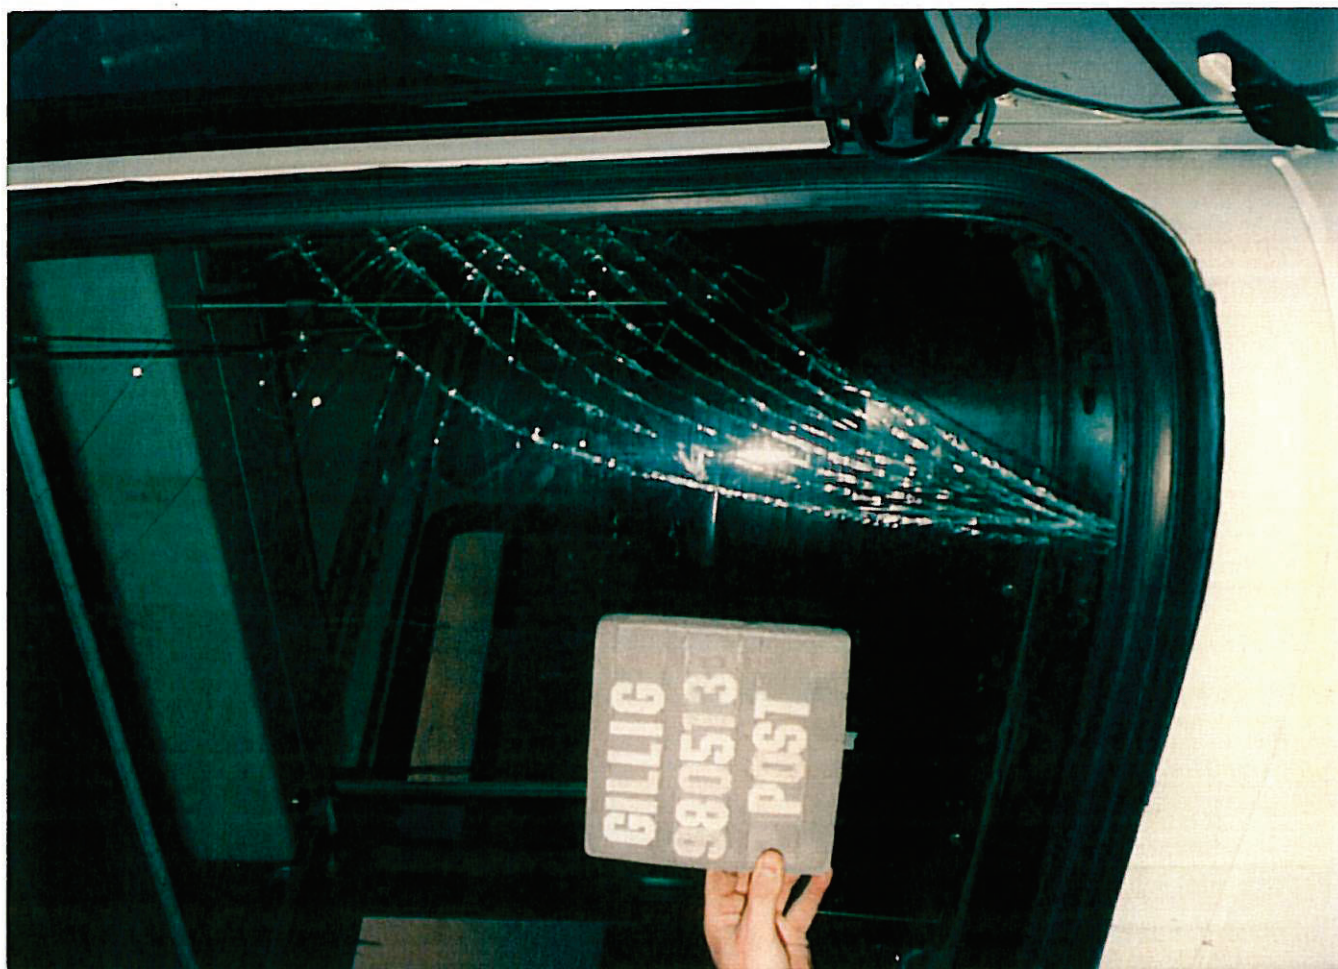
Figure A-25 Post-Test Windshield Damage Close-Up View
