### **PRE -AWARD PURCHASER'S REQUIREMENTS CERTIFICATION**

As required by Title 49 of the CFR. Part 663 - Subpart B, Department of Rail and Public Transportation (the recipient) certifies that the buses to be purchased, ADA Body-On-Chassis Cutaway (Ford Transit 11 Passenger BOC, Chevy G-Series Chassis 15 Passenger BOC, Chevy G-Series Chassis 19 Passenger BOC, Ford E-Series Chassis 14 Passenger BOC, Ford E-Series Chassis 15 Passenger BOC, Ford E-Series Chassis 19 Passenger BOC, and Ford F-Series Chassis 27 Passenger BOC (description of buses) from Forest River, Inc. (the manufacturer), are the same product described in the recipient's solicitation specification and that the proposed manufacturer is a responsible manufacturer with the capability to produce a bus that meets the specifications.

**ARBOC MOBILITY LLC  
MODEL SOM23G**

## **STARCRAFT BUS MODEL ALLSTAR-25**

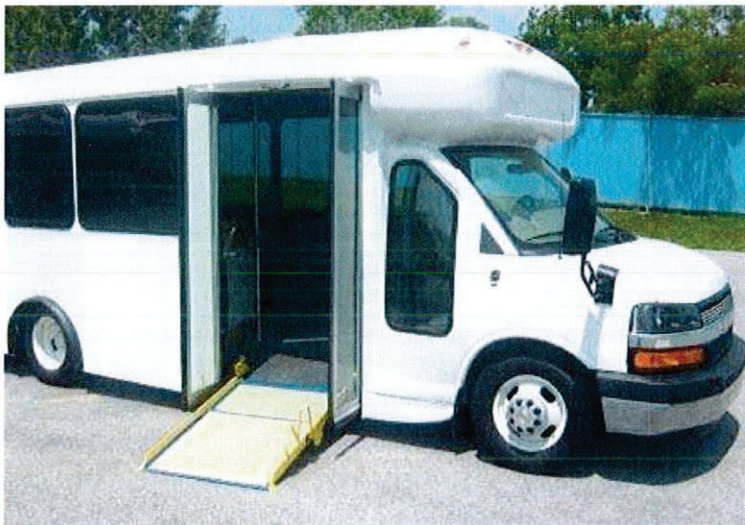
**ARBOC MOBILITY LLC  
MODEL SOM23G EQUIPPED WITH AN ARBOC  
MODEL 32 X 48 HANDICAP RAMP**

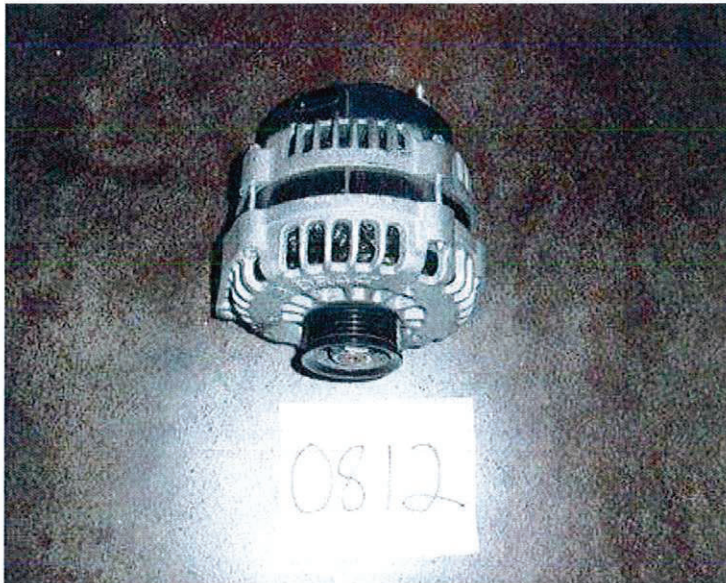
#### **ALTERNATOR REMOVAL AND REPLACEMENT (1.0 MAN HOURS)**

Subsystem	Replacement Time
Transmission	12.0 man hours
Wiper Motor	0.5 man hours
Starter	0.5 man hours
Alternator	1.0 man hours
Batteries	0.5 man hours

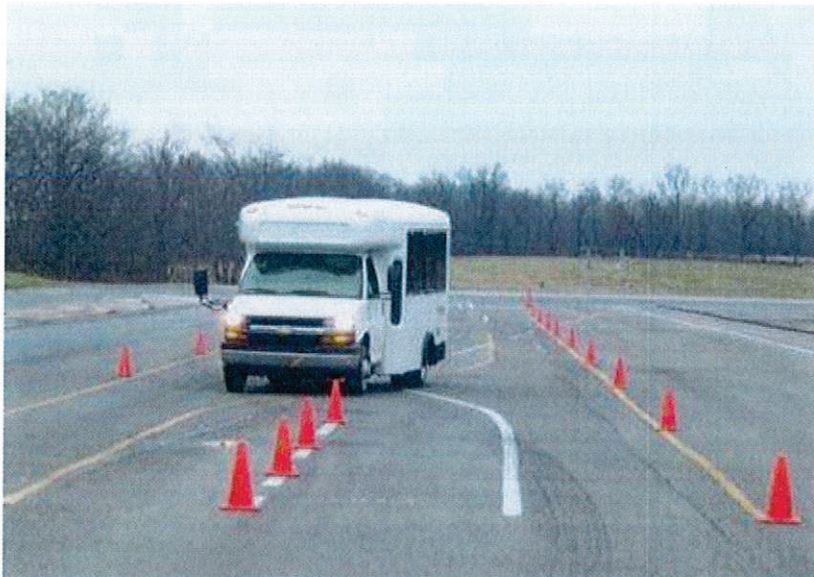
**RIGHT - HAND APPROACH**

<b>SAFETY TEST: DOUBLE LANE CHANGE</b>	
Maximum safe speed tested for double-lane change to left	45 mph
Maximum safe speed tested for double-lane change to right	45 mph
<b>Comments of the position of the bus during the lane change:</b> A safe profile was maintained through all portions of testing.	
<b>Comments of the tire/ground contact patch:</b> Tire/ground contact was maintained through all portions of testing.

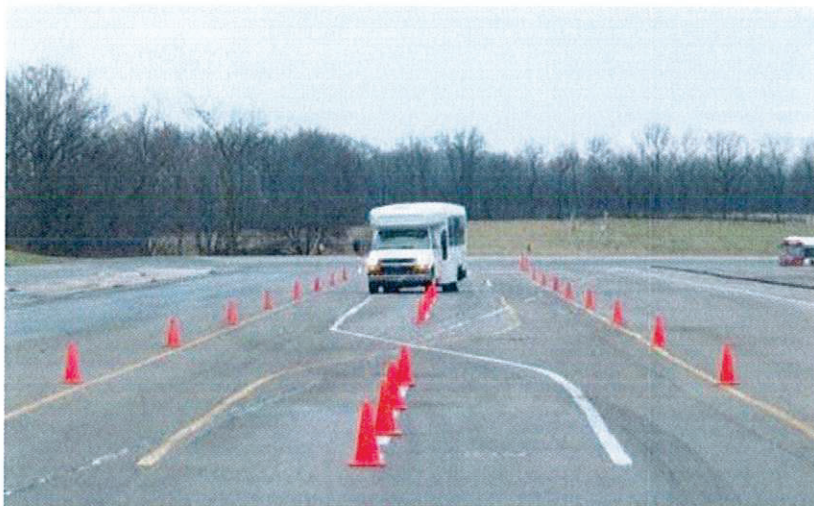
**LEFT - HAND APPROACH**

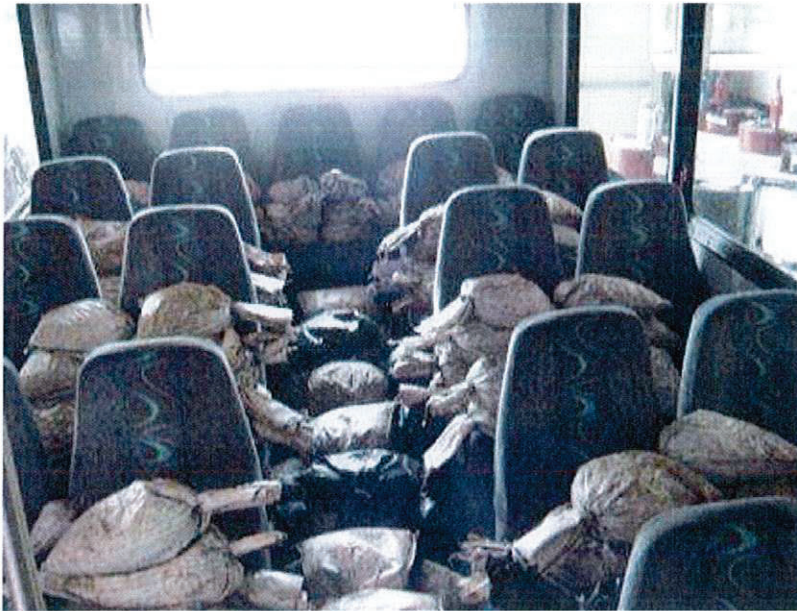
**BUS LOADED TO 2.5 TIMES GVL  
(10,875 LBS)**

The Shakedown Test produced a maximum final loaded deflection of 0.155 inches with a permanent set ranging between -0.006 to 0.006 inches under a distributed static load of 10,875 lbs. The Distortion Test was completed with all subsystems, doors and escape mechanisms operating properly. No water leakage was observed throughout the test. All subsystems operated properly.

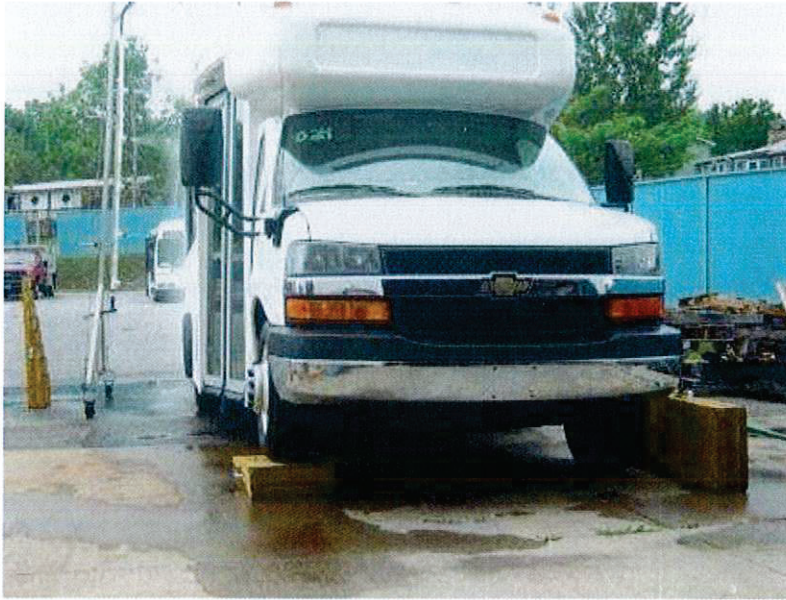
**RIGHT FRONT WHEEL SIX INCHES HIGHER**

All doors, windows, escape mechanisms, engine, steering and handicapped devices operated normally throughout the test. The undercarriage and body indicated no deficiencies. No water leakage was observed during the test. The results of this test are indicated on the following data forms.

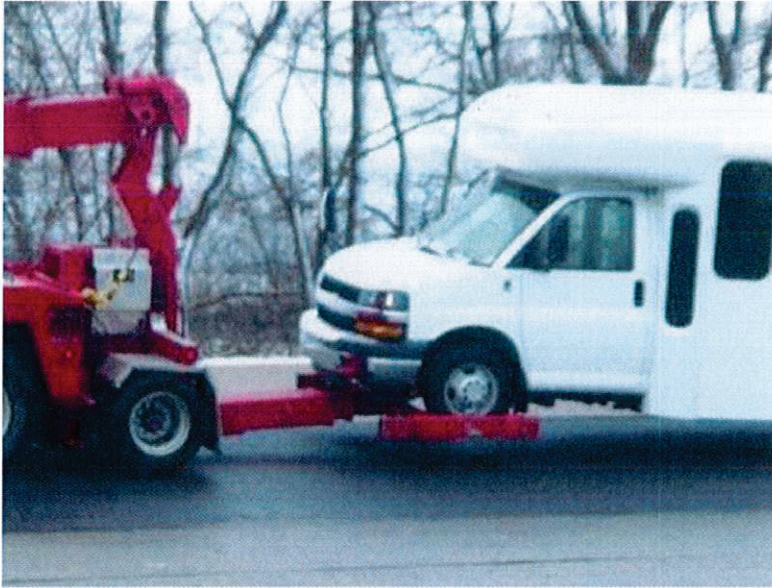
**TOWING INTERFACE**

<b>Inspect tow equipment-bus interface.</b>
<b>Comments:</b> A safe and adequate connection was made between the tow equipment and the bus.
<b>Inspect tow equipment-wrecker interface.</b>
<b>Comments:</b> A safe and adequate connection was made between the tow equipment and the wrecker.
<b>Towing Comments:</b> A front lift tow was performed incorporation a hydraulic under lift wrecker.
<b>Description and location of any structural damage:</b> None noted.
<b>General Comments:</b> No problems were encountered with the tow or towing interface.

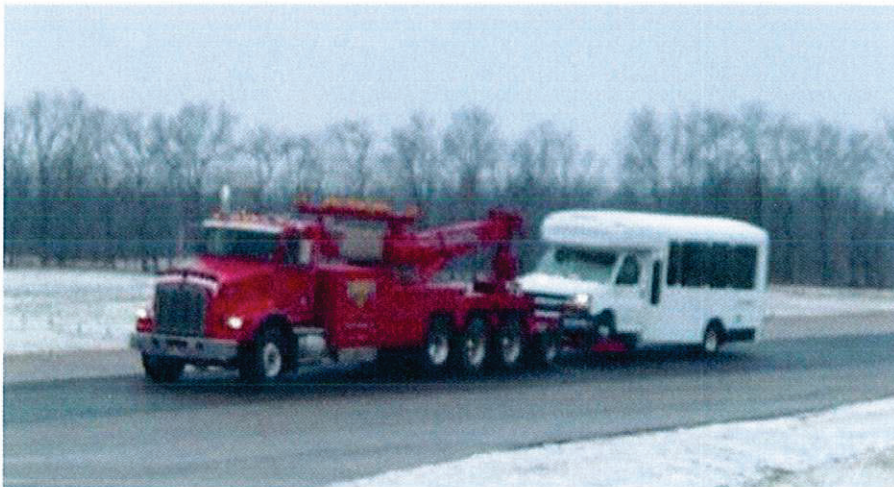
**TEST BUS IN TOW**

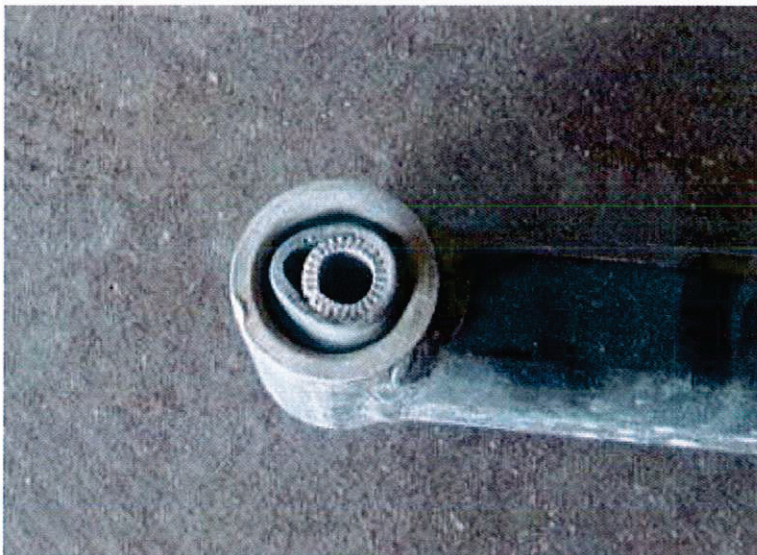
**WORN TRAILING ARM BUSHING  
(630 TEST MILES)**

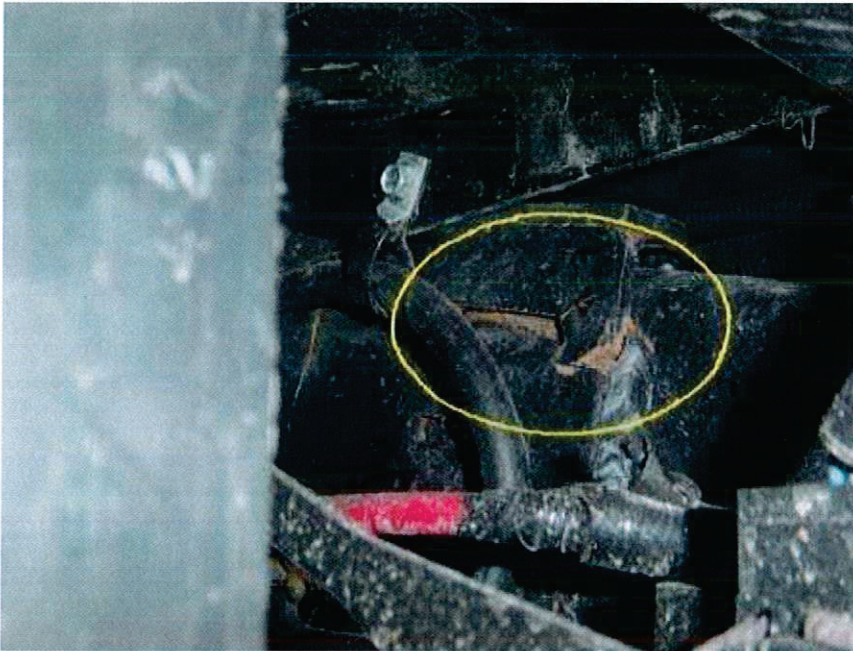
**CRACKED FRAME RAIL  
(630 TEST MILES)**

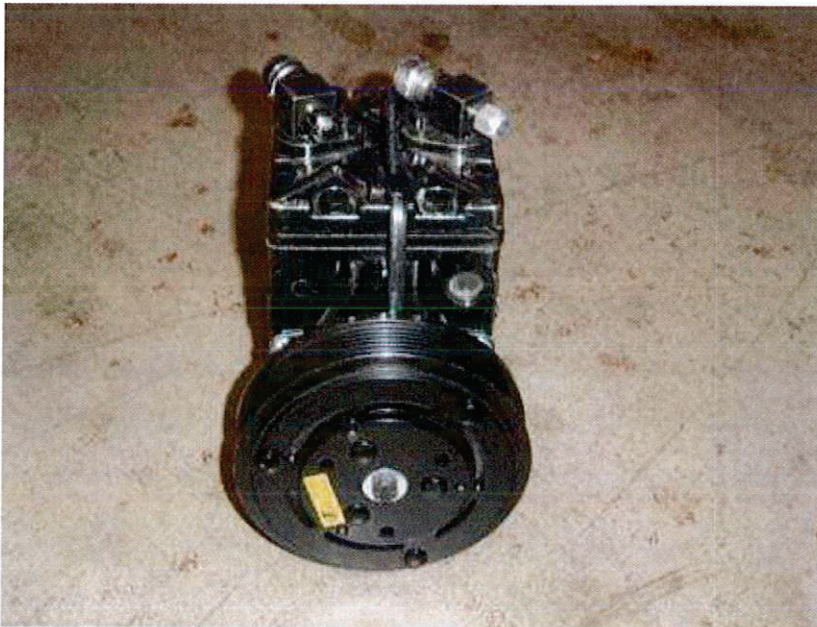
**FAILED AIR COMPRESSOR  
(1,253 TEST MILES)**

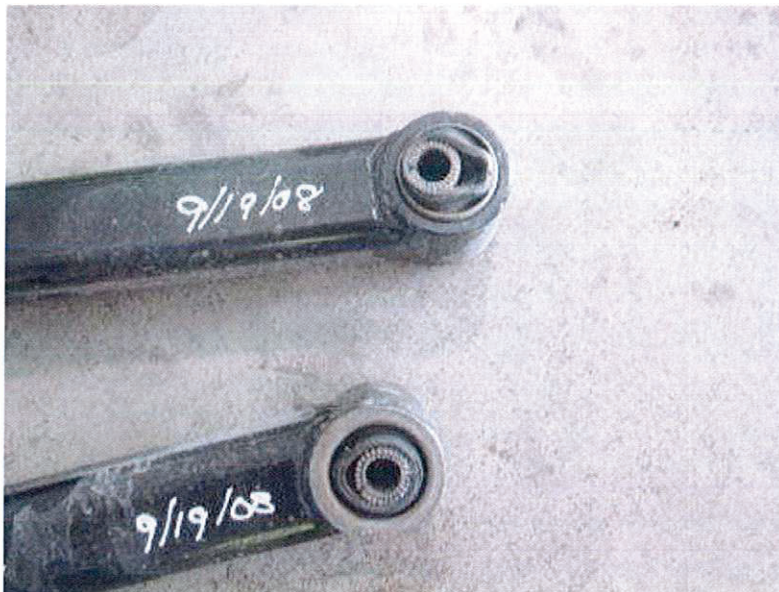
**WORN BUSHINGS IN LOWER TRAILING ARMS  
(1,253 TEST MILES)**

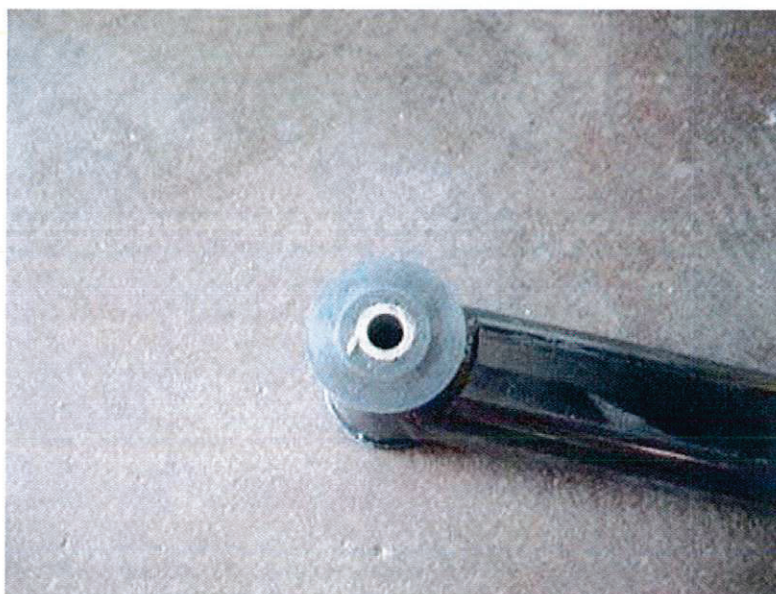
**TRAILING ARMS INSTALLED WITH NEW TYPE BUSHING  
(1,253 TEST MILES)**

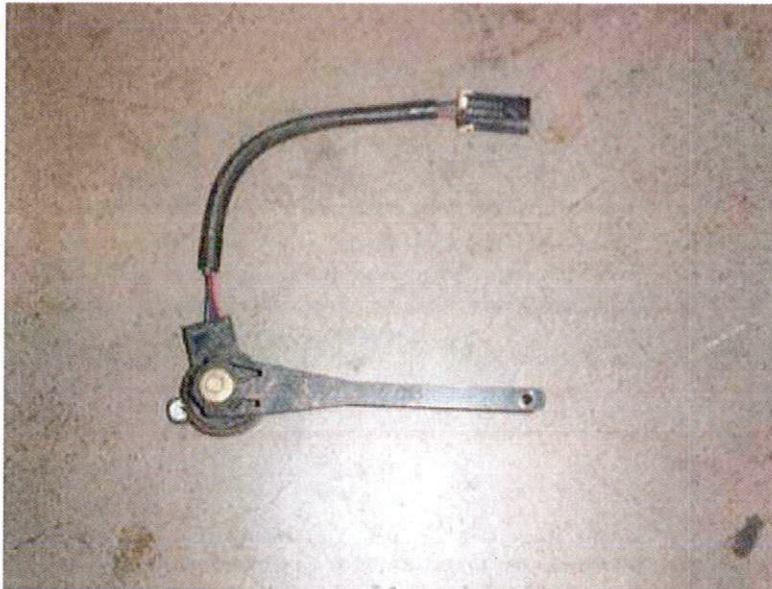
**FAILED LEVELING VALVE  
(2,659 TEST MILES)**

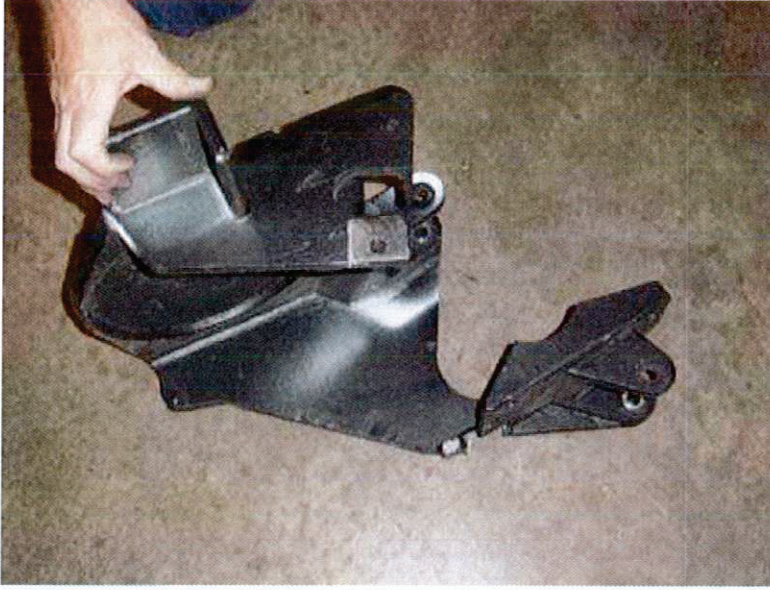
**BROKEN RIGHT REAR AIR BAG PEDESTAL  
(2,661 TEST MILES)**

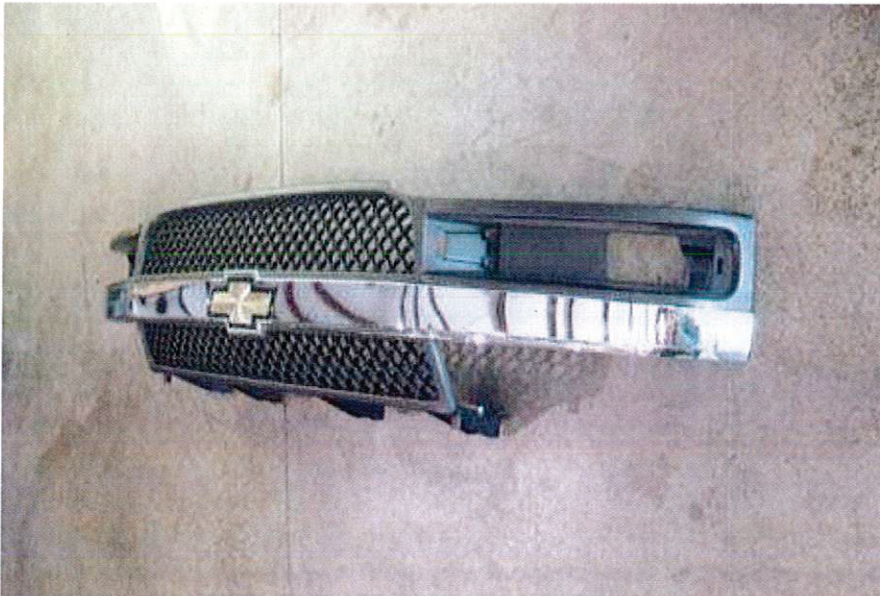
**GRILL FELL OFF  
(3,409 TEST MILES)**

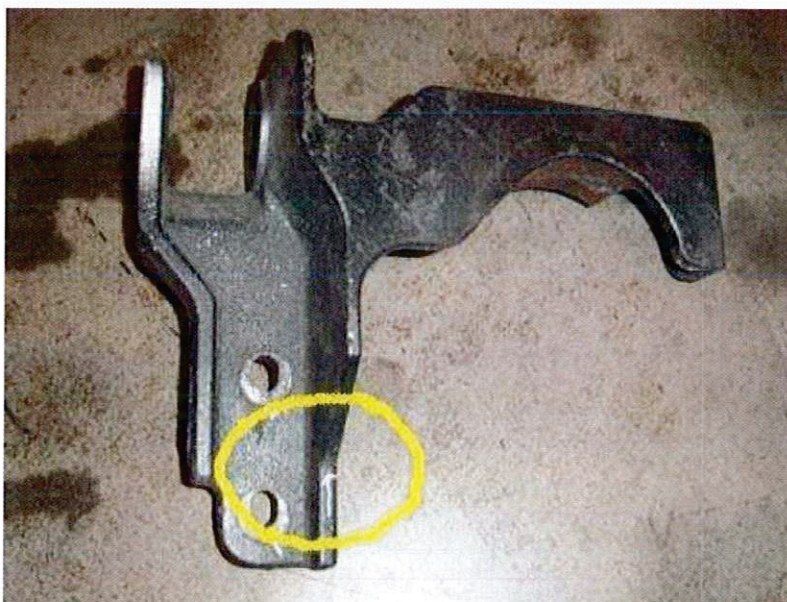
**CRACKED REAR LATERAL BAR MOUNT  
(5,071 TEST MILES)**

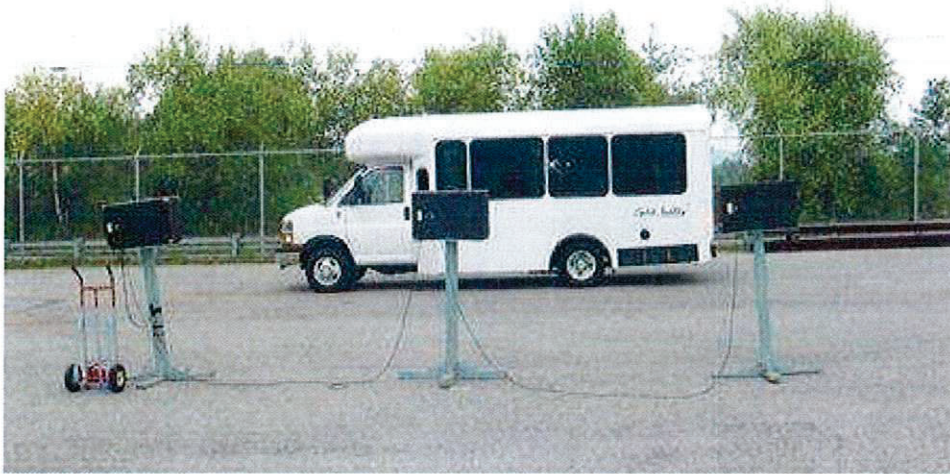
**TEST BUS SET-UP FOR 80 dB(A)  
INTERIOR NOISE TEST**

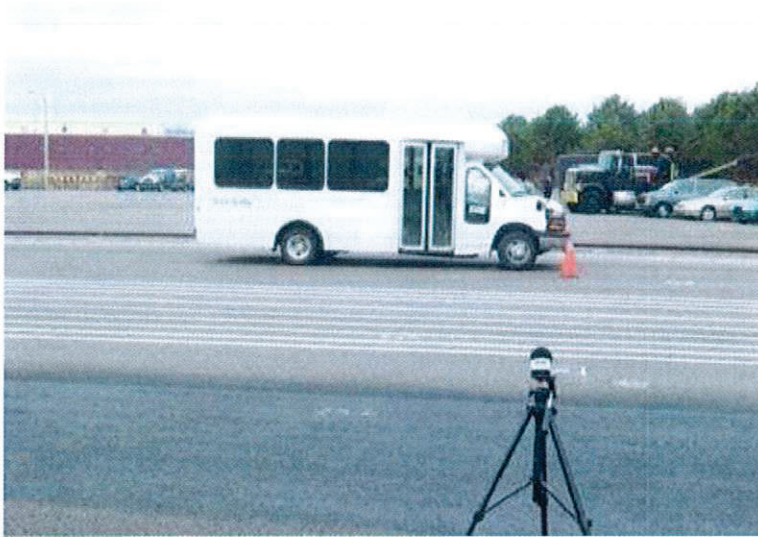
**TEST BUS UNDERGOING  
EXTERIOR NOISE TESTS**

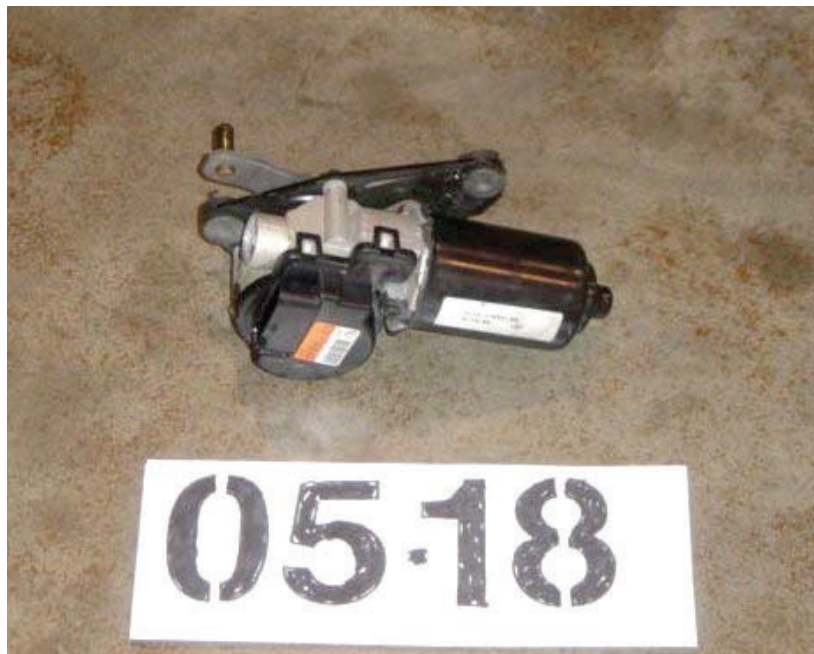
#### **WIPER MOTOR REMOVAL AND REPLACEMENT (0.50 MAN HOURS)**

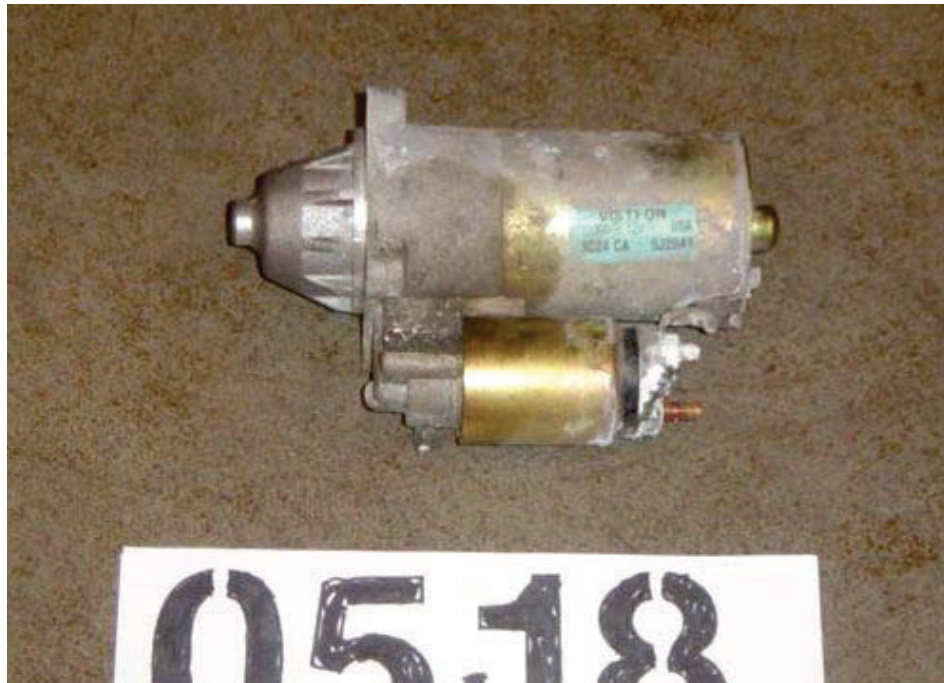
**STARTER REMOVAL AND REPLACEMENT  
(0.50 MAN HOURS)**

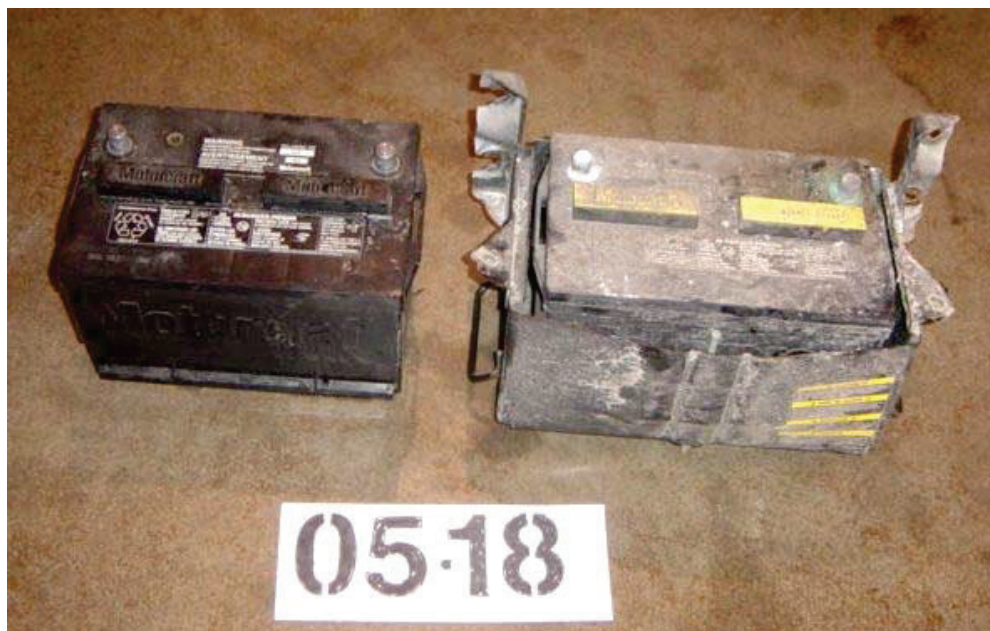
**BATTERY REMOVAL AND REPLACEMENT  
(1.00 MAN HOURS)**

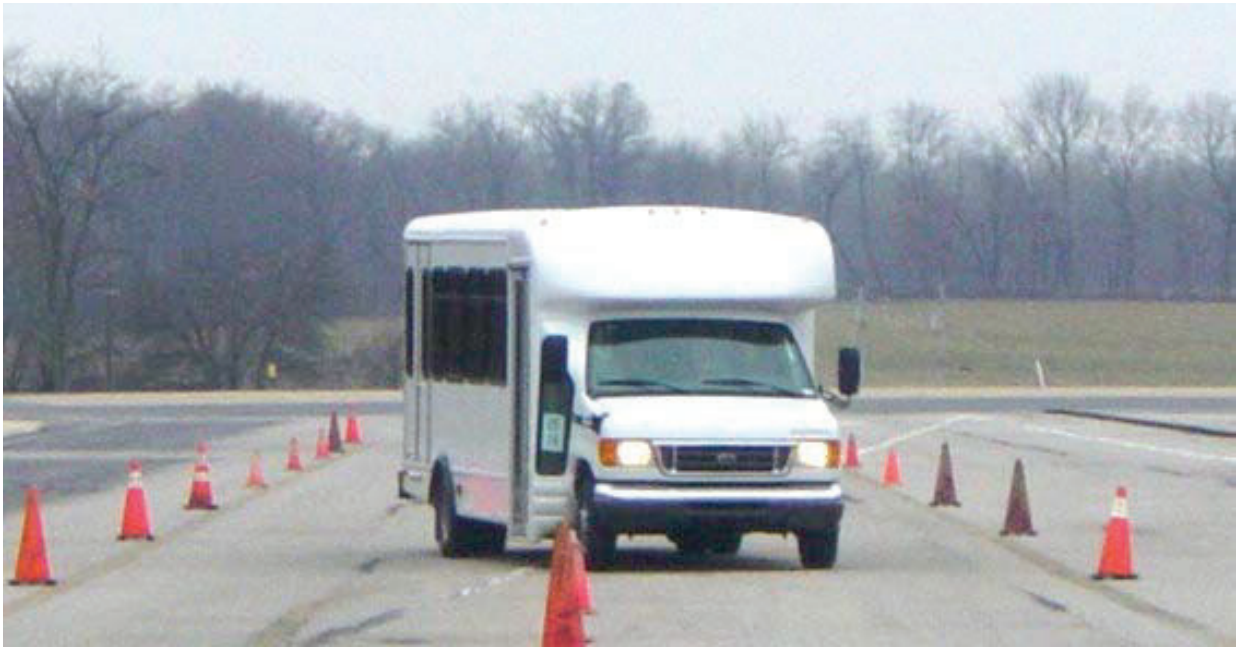
**RIGHT - HAND APPROACH**

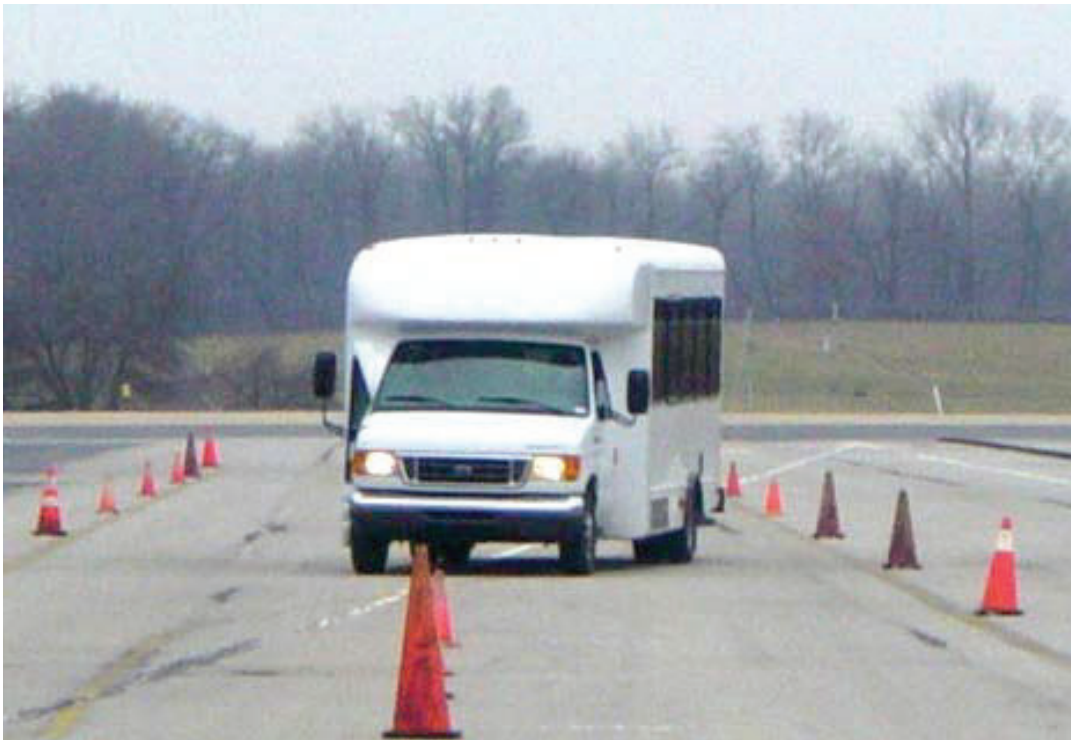
**LEFT - HAND APPROACH**

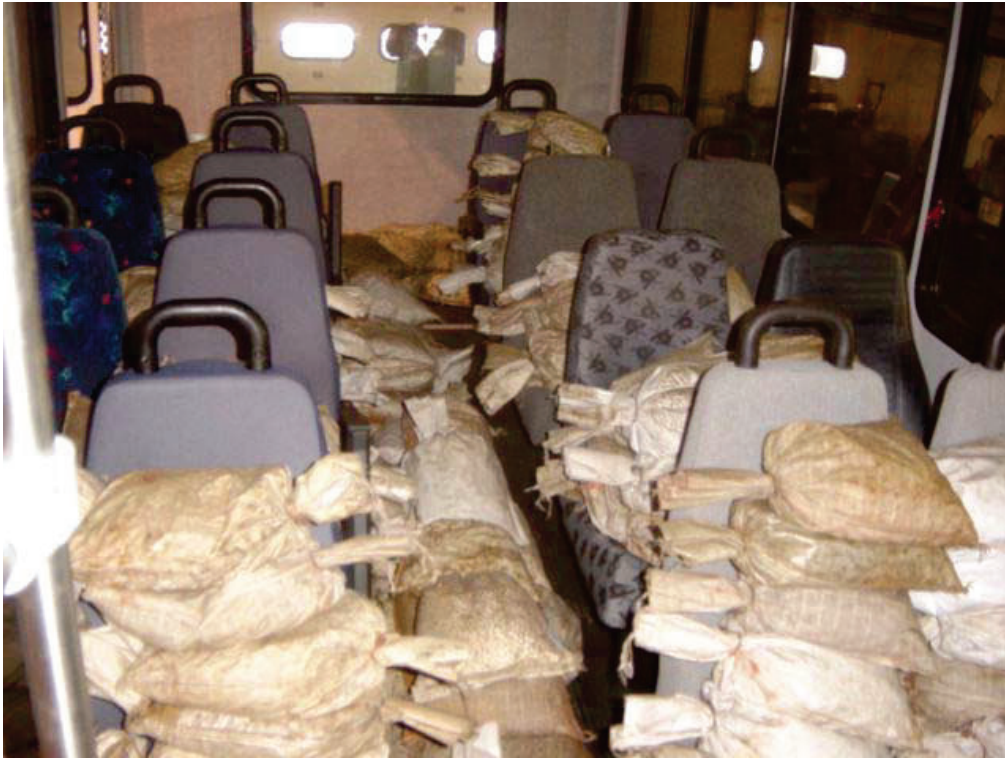
**DIAL INDICATORS IN POSITION  
BUS LOADED TO 2.5 TIMES GVL  
(10,725 LBS)**

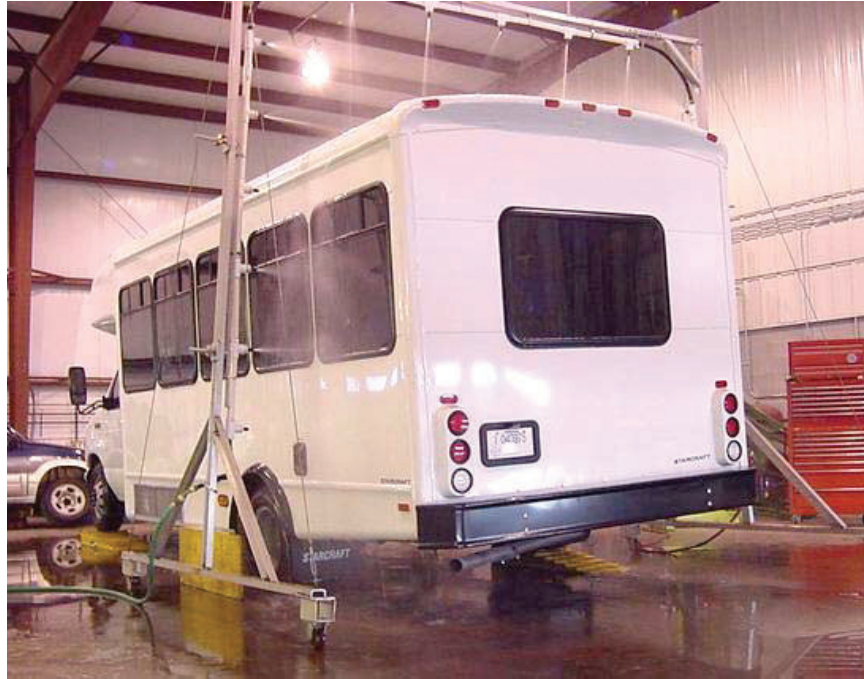
**LEFT REAR WHEEL SIX INCHES LOWER**

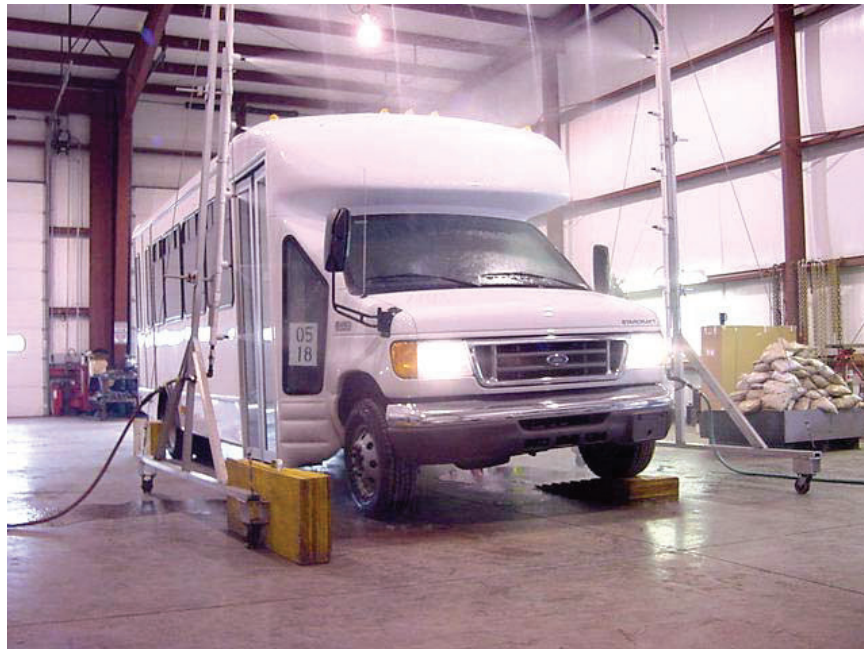
**LEFT FRONT WHEEL SIX INCHES HIGHER**

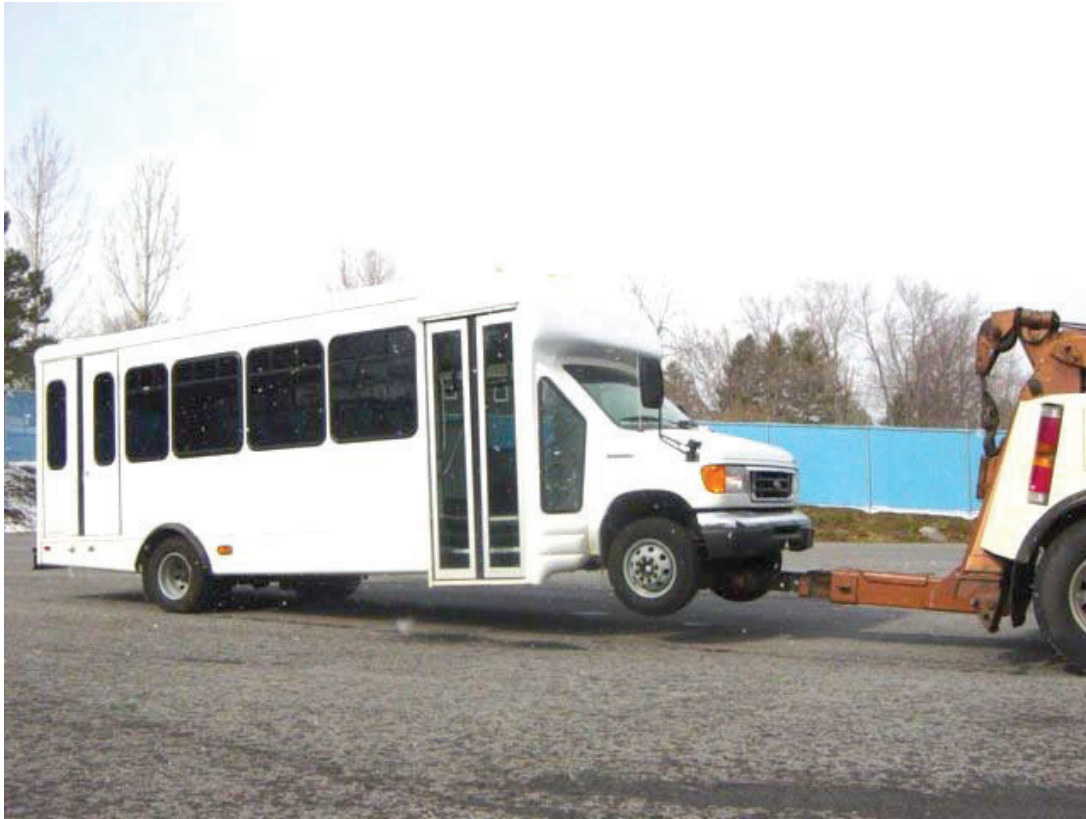
### TOWING INTERFACE

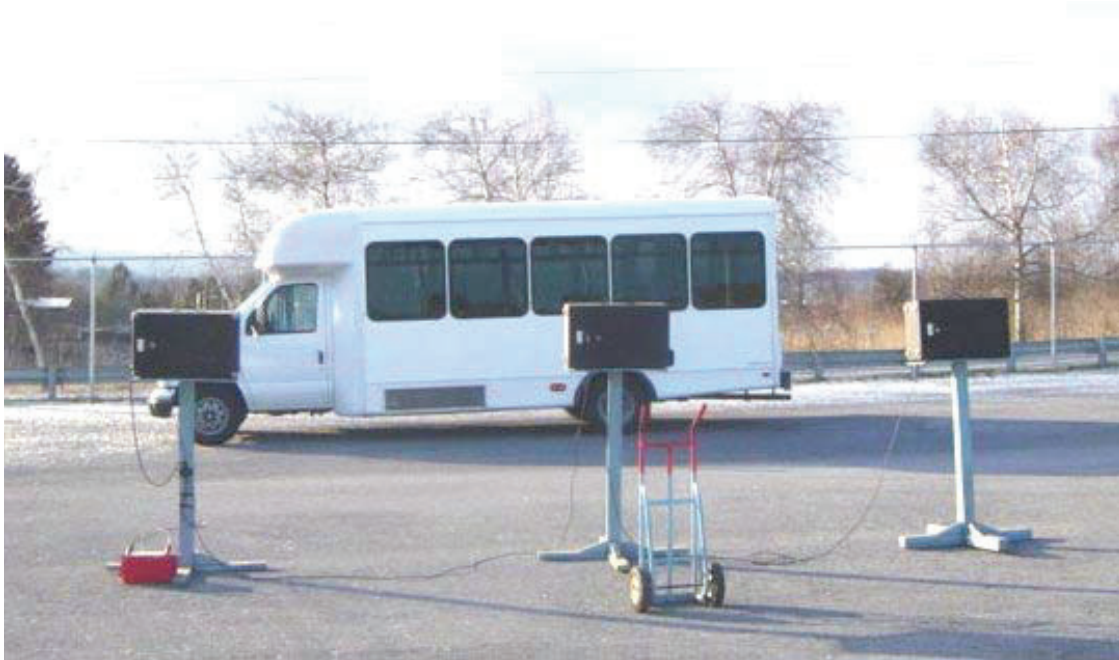
**TEST BUS SET-UP FOR 80 dB(A)  
INTERIOR NOISE TEST**

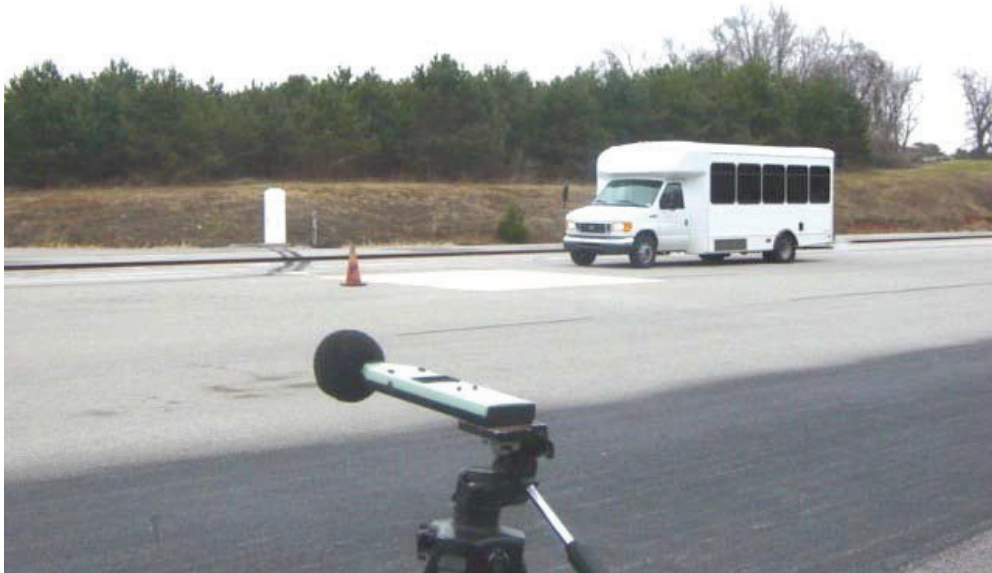
**TEST BUS UNDERGOING EXTERIOR NOISE TESTING**
